## MEMORANDUM

**Date:** December 9, 2011 **Project #:** 10323.04  
**To:** Nancy Kraushaar & John Lewis, City of Oregon City  
**From:** Hermanus J. Steyn, Pr.Eng., P.E. and Erin M. Ferguson, P.E.  
**Project:** Safety Assessment  
**Subject:** Holcomb Boulevard

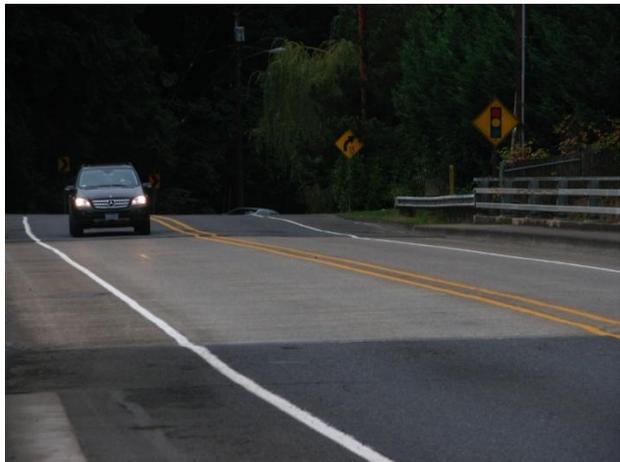
The 13700 block of Holcomb Boulevard contains a 15-mph design curve that is hidden from the view of westbound motorists because of a downhill grade beyond a vertical crest curve (see Exhibit 1). There are two advanced signs warning westbound drivers of the curve. The combination of the 15-mph design curve on a downhill grade makes it difficult for some drivers to stay in the travel lane. Historically, the curve has become known among local media, residents and emergency responders as a site of serious

**Exhibit 1 – Westbound View on  
Holcomb Boulevard**

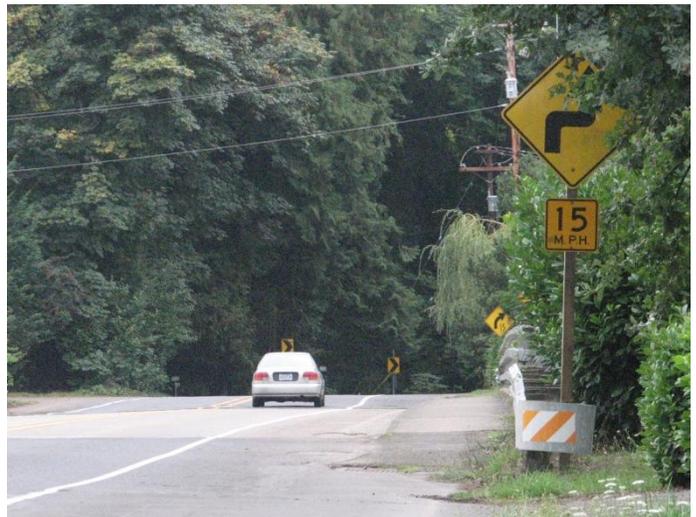
Approaching the curve from the east, there are two advanced warning signs posted on Holcomb Boulevard prior to the curve. The furthest advanced sign is located approximately 350 feet prior to the curve and the second is located just prior to where the roadway begins to curve north and downhill (see Exhibit 2). The curve itself is delineated with chevron warning signs visible for westbound (i.e., downhill) and eastbound (i.e., uphill) motorists; guardrail also follows the outside edge of the curve (see Exhibit 3).

**Exhibit 2 – Advanced Warning Signs**

The vegetation near the first advanced warning sign could be improved to provide better visibility of the sign on the westbound approach (see Exhibit 2 above).

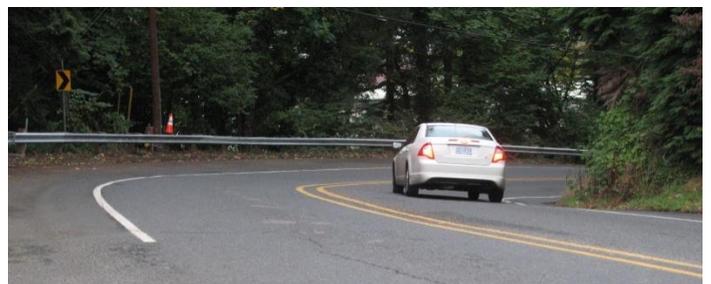
**Exhibit 3 – Guardrail along Curve**

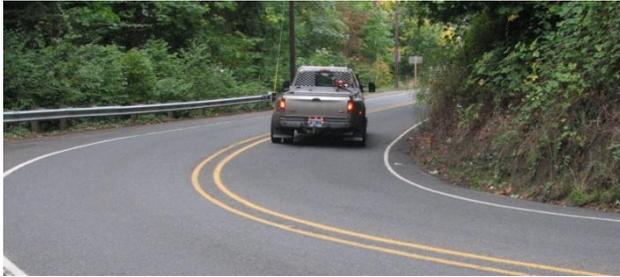
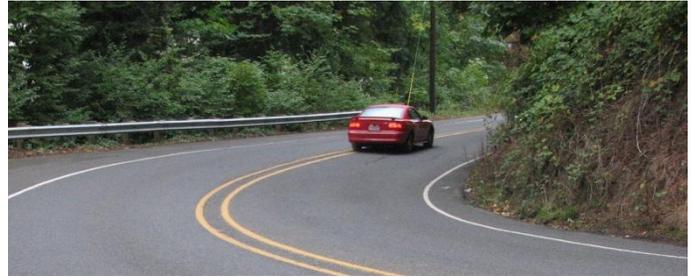
their speeds to negotiate the curve successfully. Some motorists traveling downhill were observed traveling over the inside edge lane line entering the curve and then shifted towards the centerline while exiting the horizontal curve (see Exhibit 4). Some motorists traveling uphill were observed traveling over the outside edge line onto the paved shoulder.

**Exhibit 4 – Motorists Drifting onto Centerline Exiting Horizontal Curve**

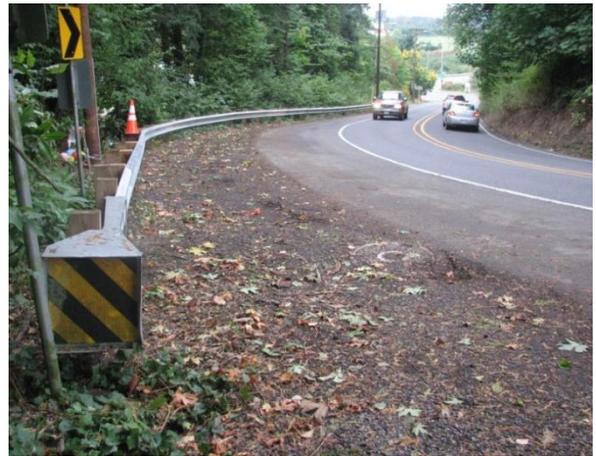
The location of the guardrail along the outside edge is set back at the edge of the dirt/gravel shoulder (see Exhibit 5). This location facilitates a potential improvement discussed in the following section. While in the field, KAI also observed opportunities to improve the roadway pavement conditions (see Exhibit 6). The current pavement conditions are not anticipated to have contributed to the crashes at this location. Repaving the roadway would help preserve the structural integrity of the roadway and prevent further rutting and/or cracking.

**Exhibit 5 – Guardrail Location**

Adjust the roadway alignment through the curve to provide a buffered space to separate eastbound (i.e., uphill) and westbound (i.e., downhill) motorists. The current paved roadway plus the gravel shoulder width provides sufficient space to realign the eastbound approach (i.e., uphill approach) to place motorists closer to the existing guardrail, which creates additional space between the opposing travel lanes. The westbound (i.e., downhill) approach can also be adjusted to soften the horizontal curve and provide a center median buffer area. Figure 2 illustrates the design concept.

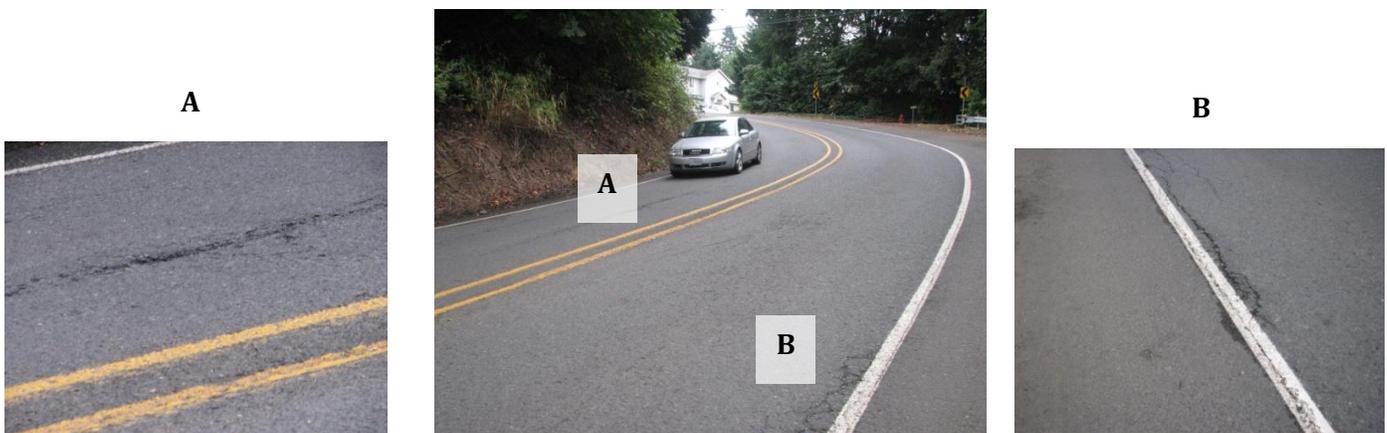
**Exhibit 6 – Pavement Conditions**

In the longer term, we suggest the City consider installing the speed feedback sign, as well as adjusting the roadway alignment through the curve to provide additional space for motorists to negotiate the curve. This adjustment could be undertaken when the City resurfaces Holcomb Boulevard to improve the pavement conditions.
