TECHNICAL MEMORANDUM

Molalla Avenue at Barclay Hills Drive Intersection

Safety Assessment

Date: January 2 2012 Project #: 10323.4

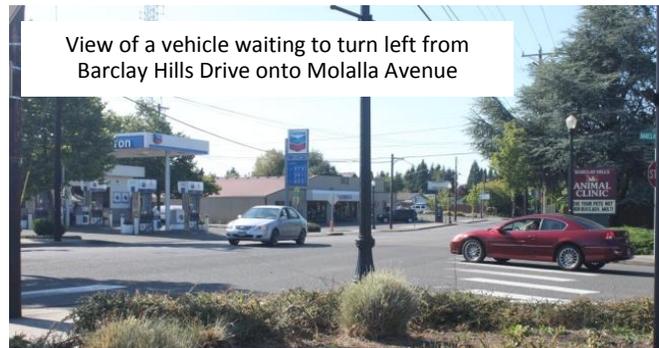
Barclay Hills Drive intersects with Molalla Avenue at a slightly-skewed T-intersection. Since the south leg of Molalla Avenue has a raised median, left-turning vehicles from Barclay Hills Drive are required to find simultaneous gaps in both directions rather than make a traditional two-stage left-turn.

The public has raised concerns about the difficulty to complete this westbound left-turn. No additional crash data was available to confirm safety issues at this intersection.

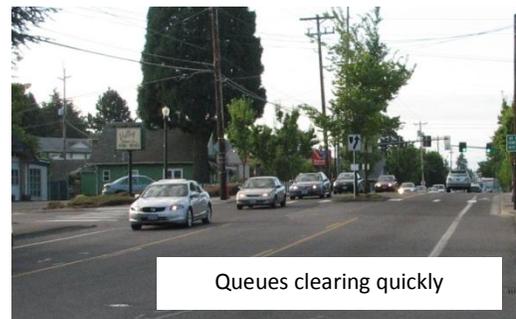
- During the morning peak period, there were often long queues on Molalla Avenue at the Hilda Street signal but they cleared during each signal cycle. Vehicles turning left from Barclay Hills Drive could find a gap with limited delay.

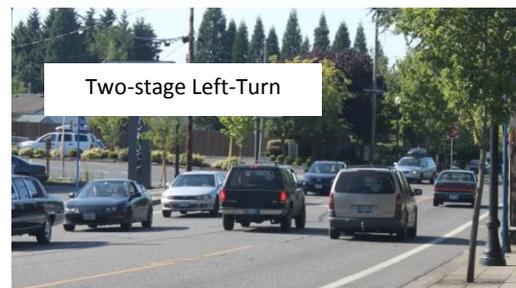
- During the evening peak period, vehicles turning left from Barclay Hills Drive had longer delays compared to the morning peak period. A common contributor to delay for left-turning vehicles on Barclay Hills Drive were vehicles in the two-way center-turn lane going from Molalla Avenue southbound to Barclay Hills Drive eastbound or from Molalla Avenue northbound to the Chevron gas station on the west side of Molalla.

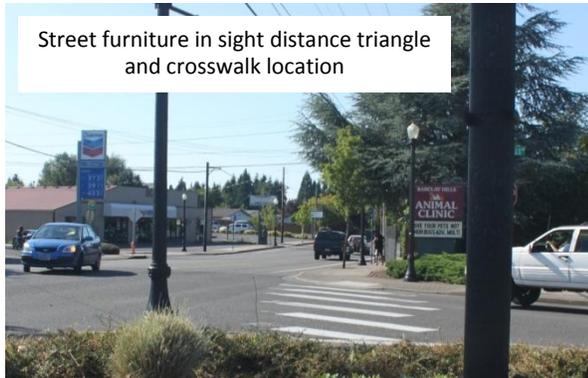
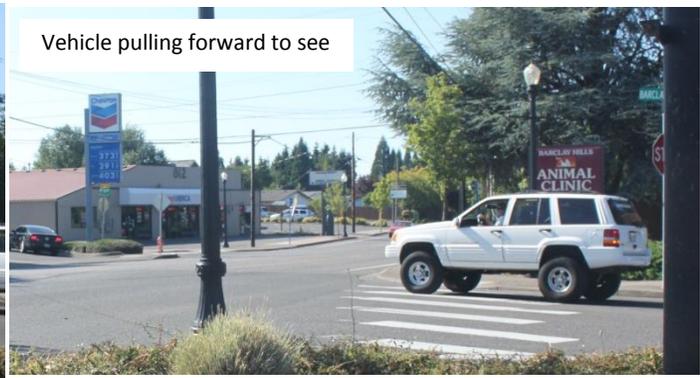
- While motorists from the west side (Chevron gas station) can complete a two-stage left by using the two-way center-turn lane, motorists from Barclay Hills Drive need to find a gap in both directions.
- Drivers turning in either direction from Barclay Hills had to creep forward past the stop bar and across the striped crosswalk to adequately evaluate whether a gap was acceptable in both directions to pull into traffic.

In addition, the City may consider working with property owners and the neighborhood association to minimize private sign obstructions within the vision triangles to improve intersection sight distance.

We recommend the City pursue the second option with the possibility of restriping Barclay Hills approach to a three lane cross section and clearing the intersection sight distance triangles. Converting the constructed and well-utilized pedestrian crosswalk into a two-way left turn lane would be costly and would deprive the pedestrians of a safe and accessible place to cross Molalla Avenue. Rather, it is advised that the City reach out to the residents of the eastern and northeastern neighborhood to use the signalized intersection at Hilda Street for an alternate access to southbound Molalla Avenue. Even though this could result in extra trip length for vehicles, it will likely decrease their delay in making the left turn and reduce the probability of crashes because the turn movements are occurring at a signal.

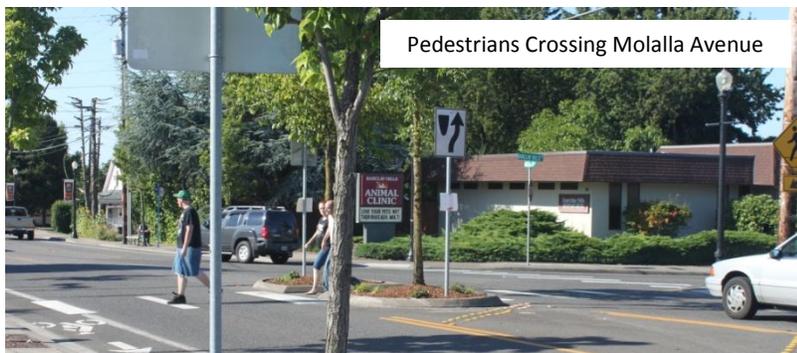
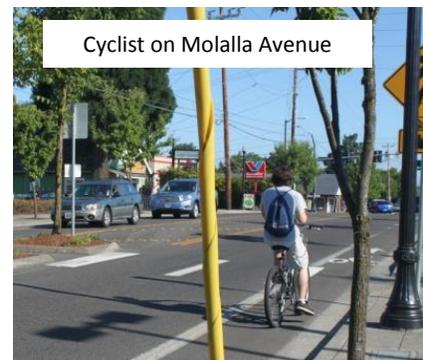
- During the morning and evening peak periods, the pedestrian crossing and refuge area were frequently used and it appears that the currently location is appropriately located based on the natural walking paths and other site constraints.
- Several bicycles were observed to travel along both the designated bicycle lanes and the sidewalk facilities.

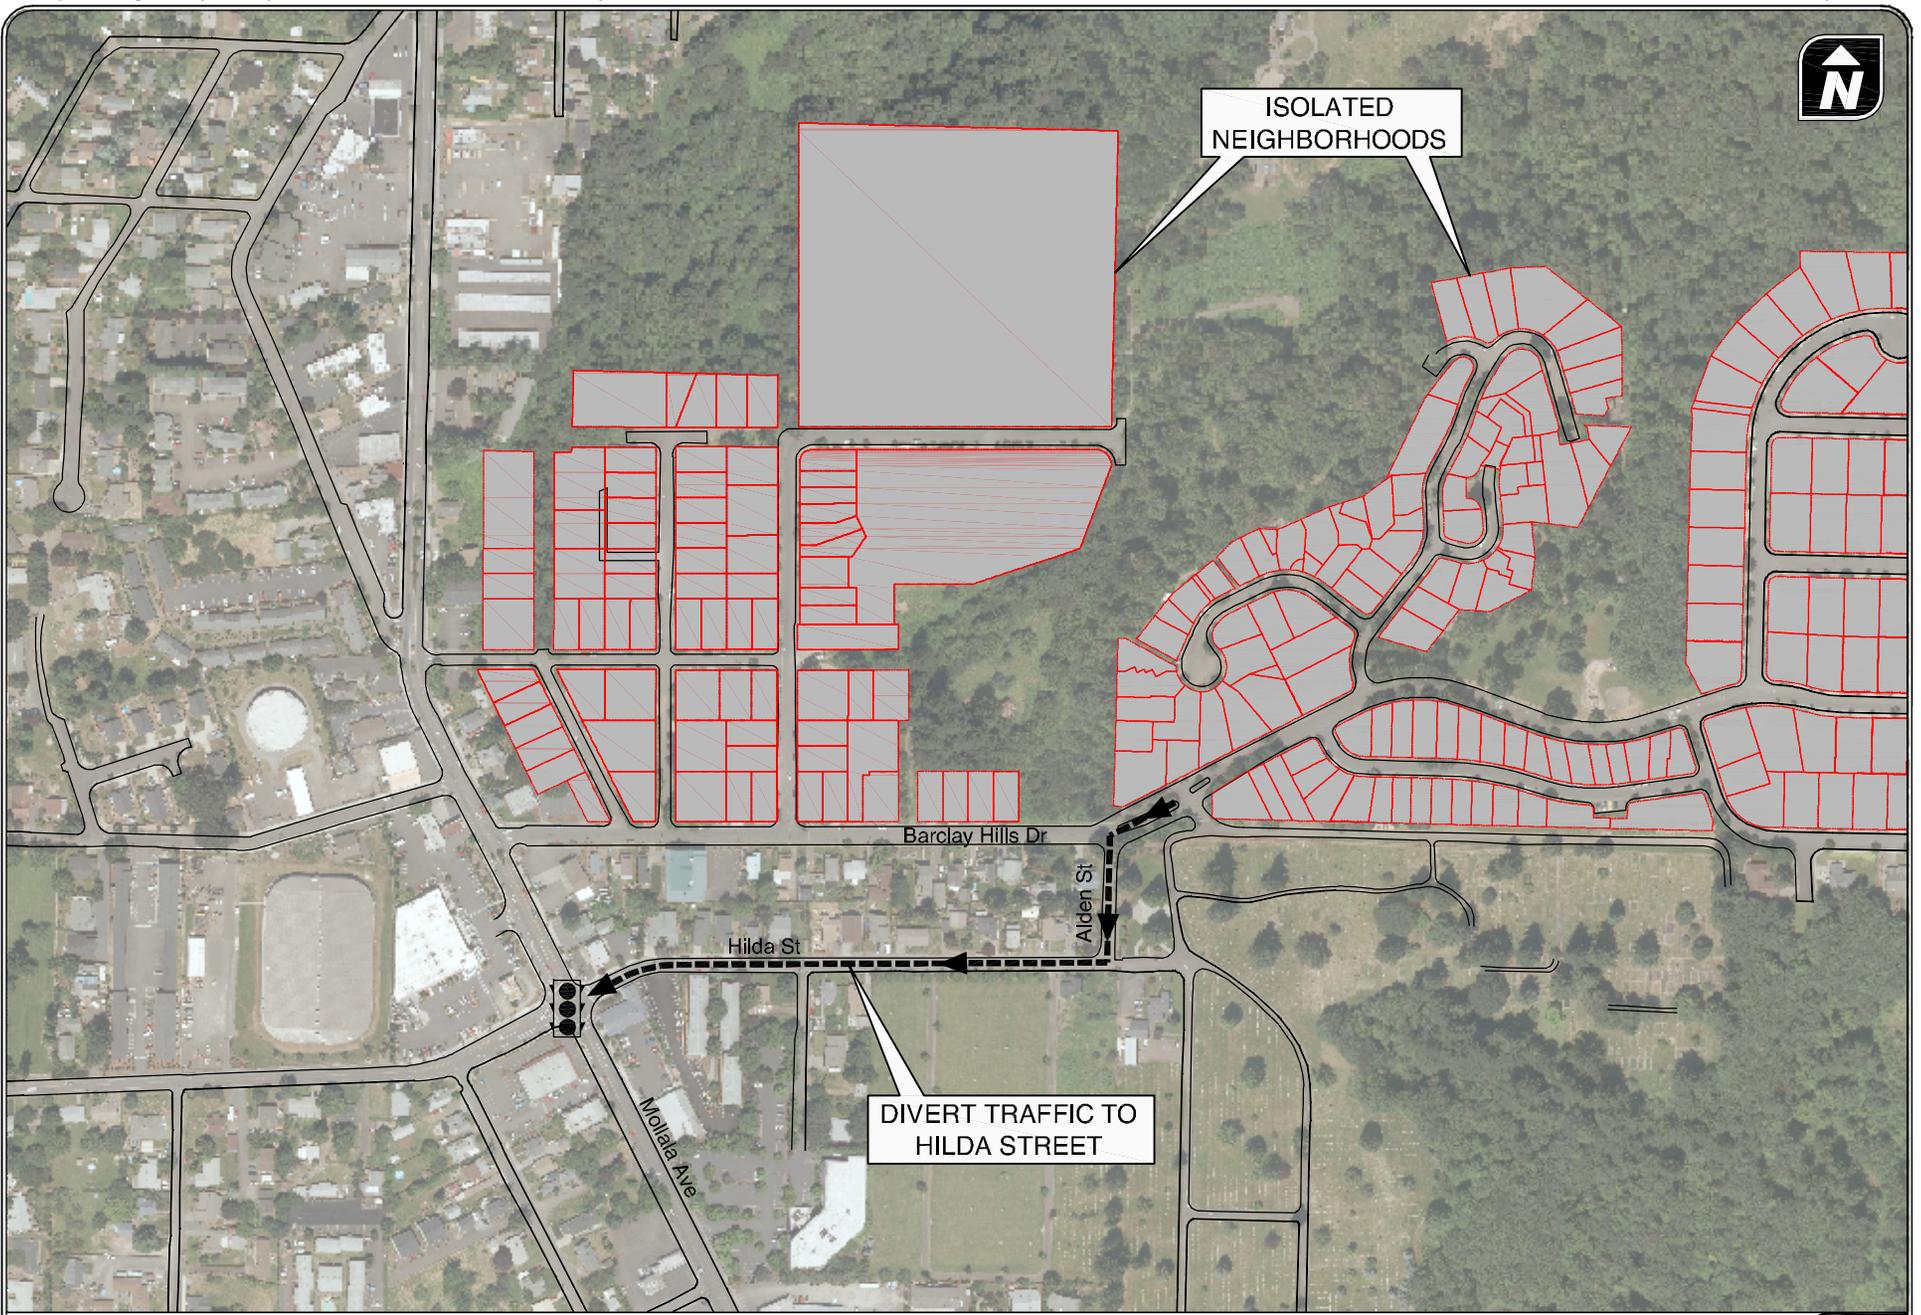
FIGURE
2

DIVERT TRAFFIC TO HILDA STREET

Consider developing a public outreach campaign aimed at the residential communities to the east of Alder Street encouraging drivers to use Hilda Street instead of Barclay Hills Drive for access onto Molalla Avenue to travel south. The Hilda Street/Molalla Avenue is signalized, and would provide an alternate route onto southbound Molalla Avenue from the residential areas. Motorists will have a choice to continue using the Barclay Hills Drive intersection, or divert to Hilda Street. Figure 2 illustrates the transportation network and the potential trip diversion to access at the Hilda Street signal. The isolated neighborhoods to east and northeast of intersection should be reminded of the signalized intersection at Hilda Street.
