DAVID EVANS
AND ASSOCIATES INC.

MEMORANDUM

DATE: February 3, 2009
TO: Nancy Kraushaar, PE
FROM: John Replinger, PE & Joshan Rohani
SUBJECT: Safety and Operations Issues in the Vicinity of Warner Parrott/Central Point and Warner-Milne/Leland/Linn
PROJECT:
PROJECT NO: ORCT00090009
COPIES:

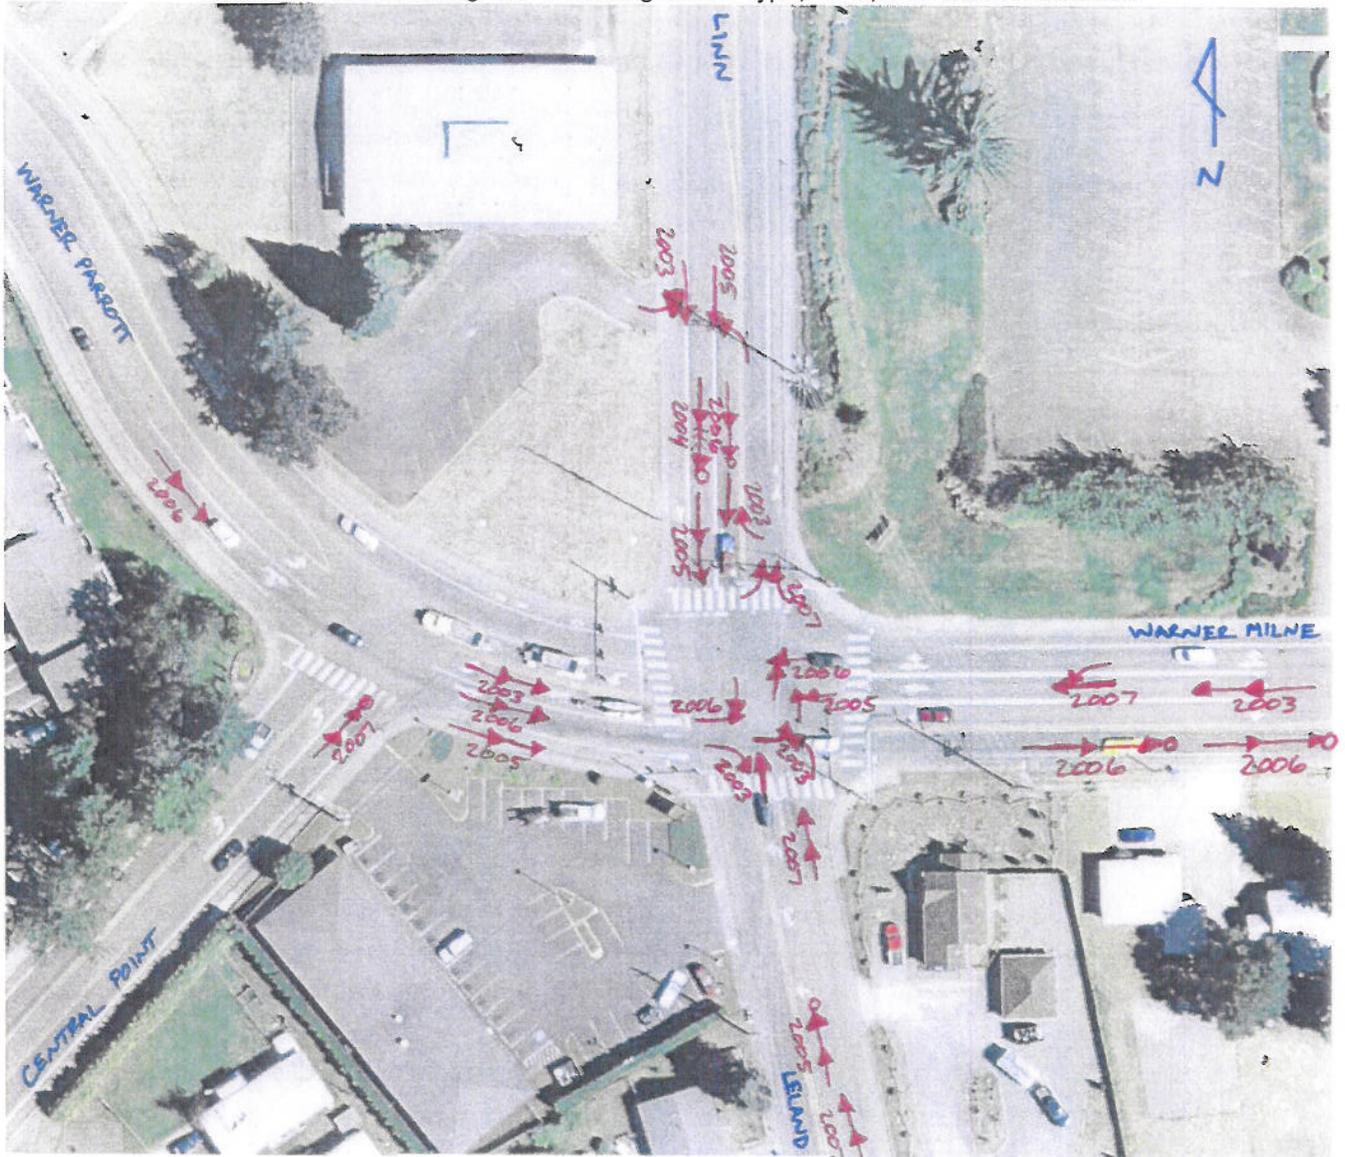
Exhibit 1. Collision Diagram: Indicating Crash Type, Year, and General Location

The number and proportion of rear-end crashes is typical of signalized intersections. A typical rear-end crash can involve an inattentive driver who fails to notice when a car ahead stops abruptly. A detailed review of crash types and locations does not suggest any surprising crash pattern that might be attributable to the close proximity of intersections. The crash frequency and types observed at this location are within reason for an intersection with moderately high traffic volumes. The adjacent access points to the Savage Mini Mall and the school do not appear to have contributed to the crashes at the intersections. There were zero reported crashes that involved turning into or out of the mini mall access points. Two turning-related crashes involved the school access on Linn Avenue, though one of those involved a vehicle making an exiting left turn that is now prohibited. No turning-related crashes occurred at the intersection of Warner Parrott Road/Central Point Road. The crash data suggests that the majority of crashes that occurred within the analysis area were due to driver errors such as following too closely/inattention (13) and failure to yield right-of-way (6). **Exhibit 1** is a collision diagram that illustrates crashes by year, type, and general location.
