Oregon Historic Site Form

Miller, Capt Sebastian, House
 402 McLoughlin Blvd
 Oregon City, Clackamas County

Canemah Historic District RLS Survey Update 2007 Survey & Inventory Project

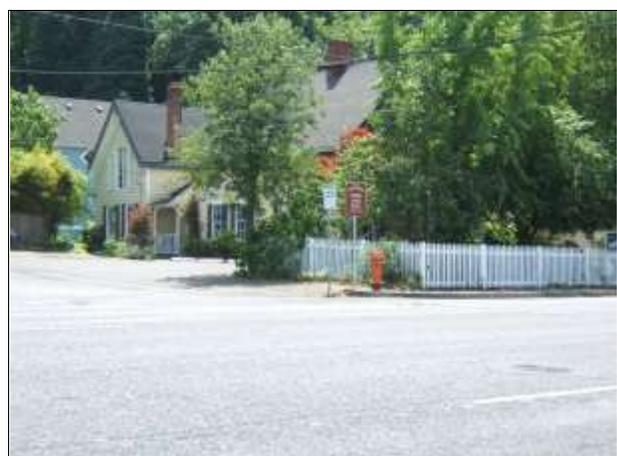
Northeast facade, looking southwest
