sisul-18-1-gi

GEOTECHNICAL ENGINEERING SERVICES Infiltration Evaluation 16362 Hiram Lane – Oregon City

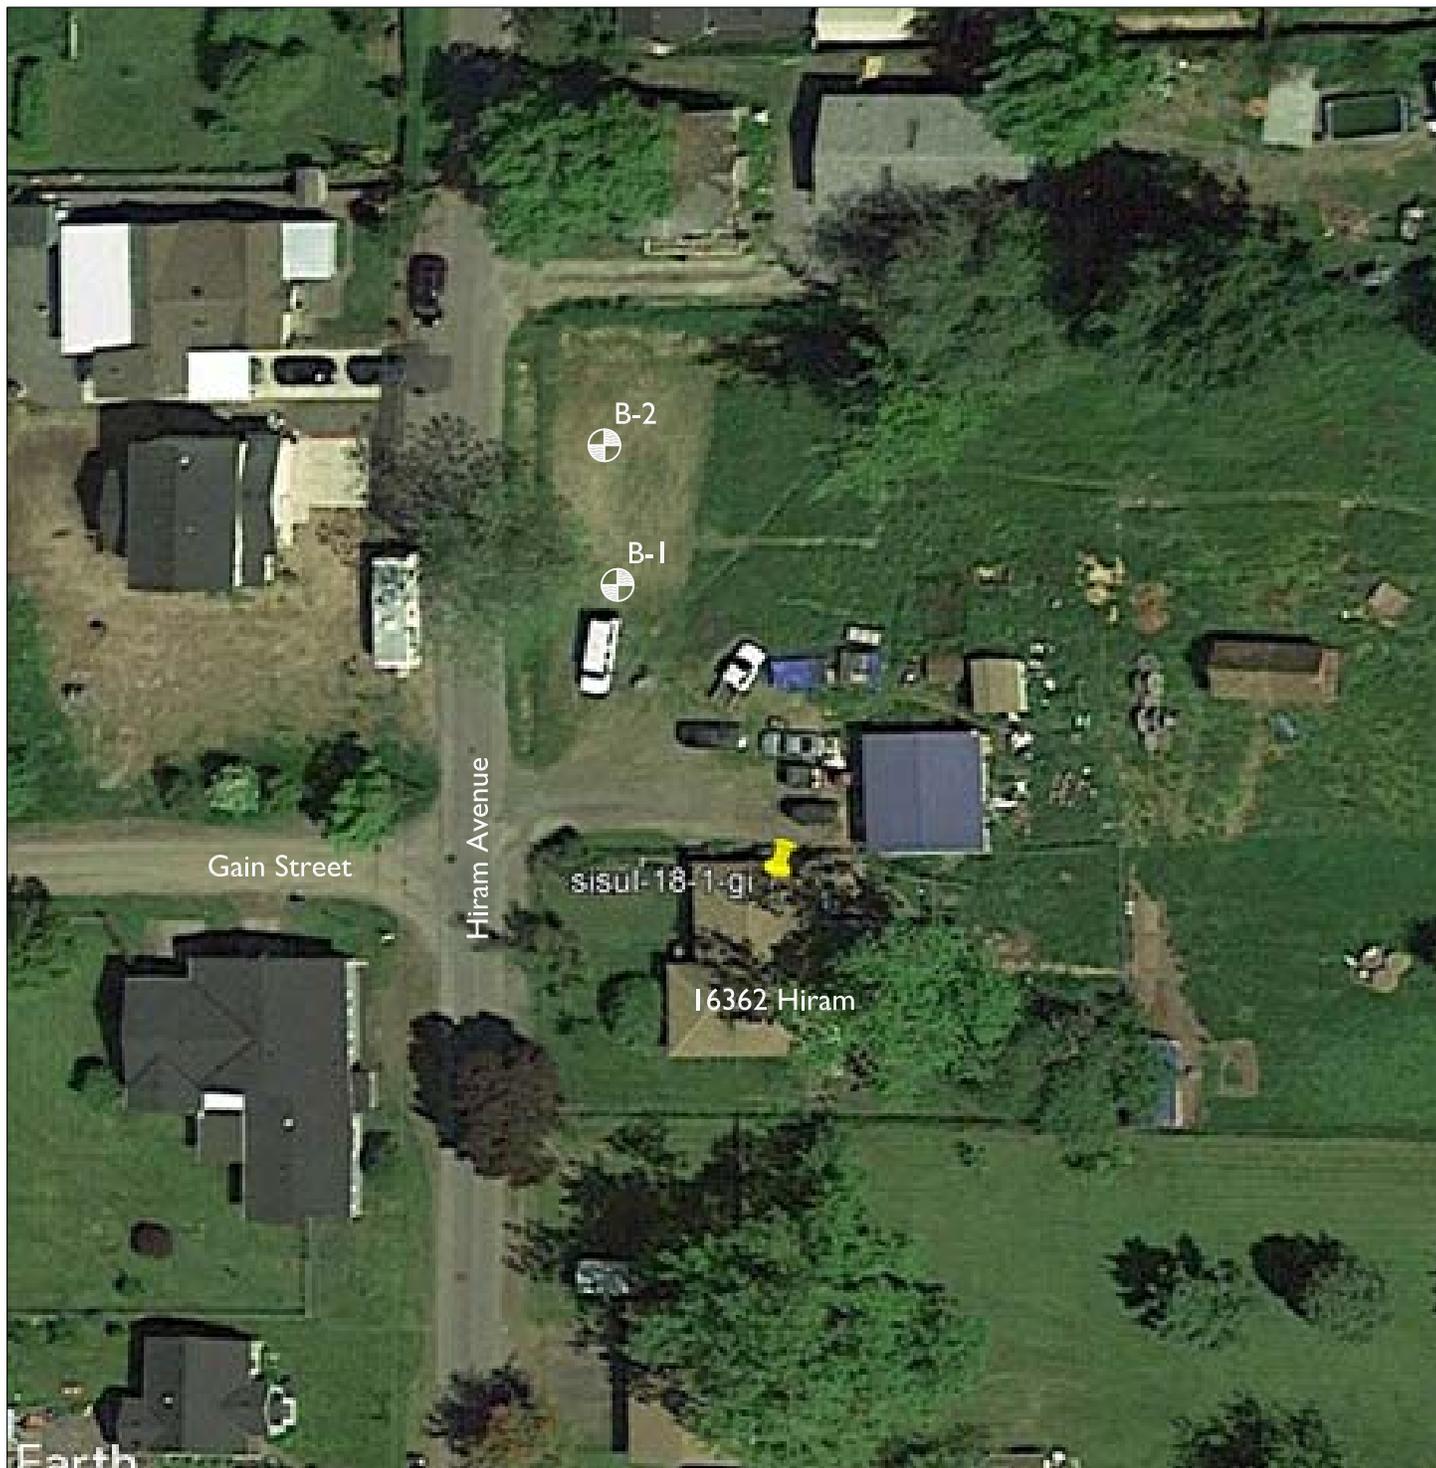
SITE PLAN
sisul-18-1-gi

The site was explored on January 26, 2018 by boring two hand augers to depths of up to 8 feet. Approximate exploration locations are shown on the attached **Site Plan**.
