TECHNICAL MEMORANDUM

Molalla Avenue at Barclay Hills Drive Intersection

Safety Assessment

Date: January 2 2012 Project #: 10323.4

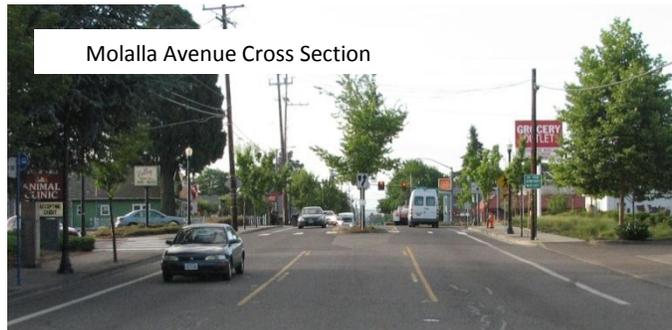
To the north of this intersection, Molalla Avenue has a two-way center-turn lane, and immediately south of the intersection a landscaped median provides a pedestrian refuge for an unsignalized crossing. There are bicycle lanes on Molalla Avenue in both directions. The speed limit along Molalla Avenue is 30 miles per hour. TriMet bus stops exist on either side of the north leg of Molalla.
