# TECHNICAL MEMORANDUM

RE: 3.3.3B - TM#6: Most Promising Alternatives  
McLoughlin Boulevard Enhancements - 10th Street to tumwata village

## Executive Summary

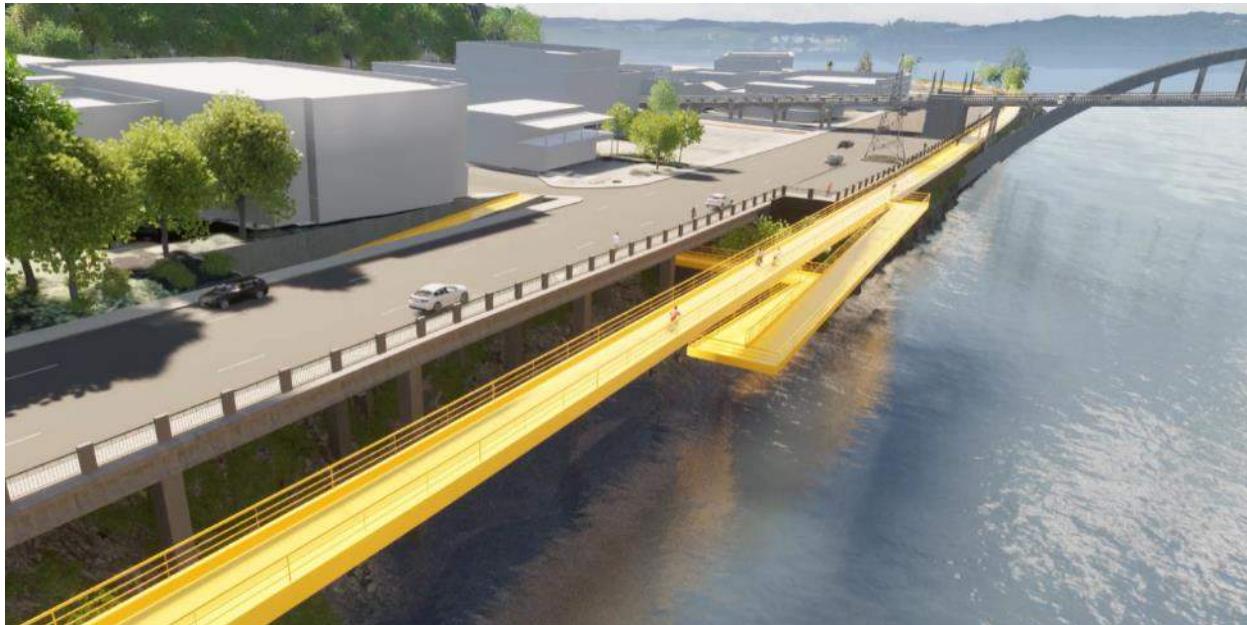
Southwest of the Historic Arch Bridge, the shared-use path runs parallel to the seawall connecting to the planned open space and tumwata village development. Figure 1 illustrates the conceptual rendering for Alternative 1B: High Route (Refined) and Figure 2 illustrates the conceptual alignment as an aerial view.

**Figure 1. Alternative 1B: High Route (Refined) Concept Design**

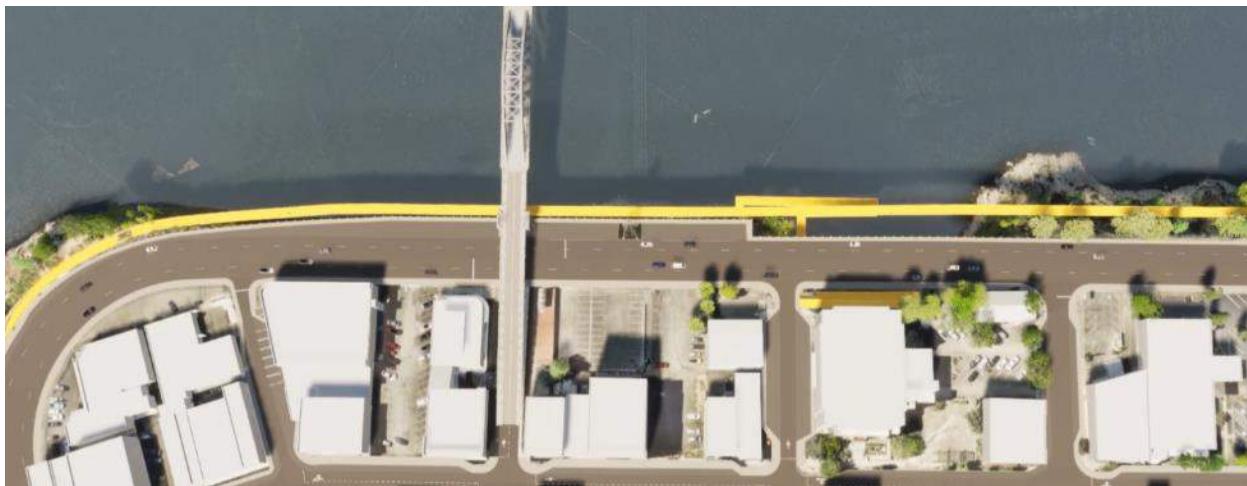
**Figure 2. Alternative 1B: High Route (Refined) Alignment**

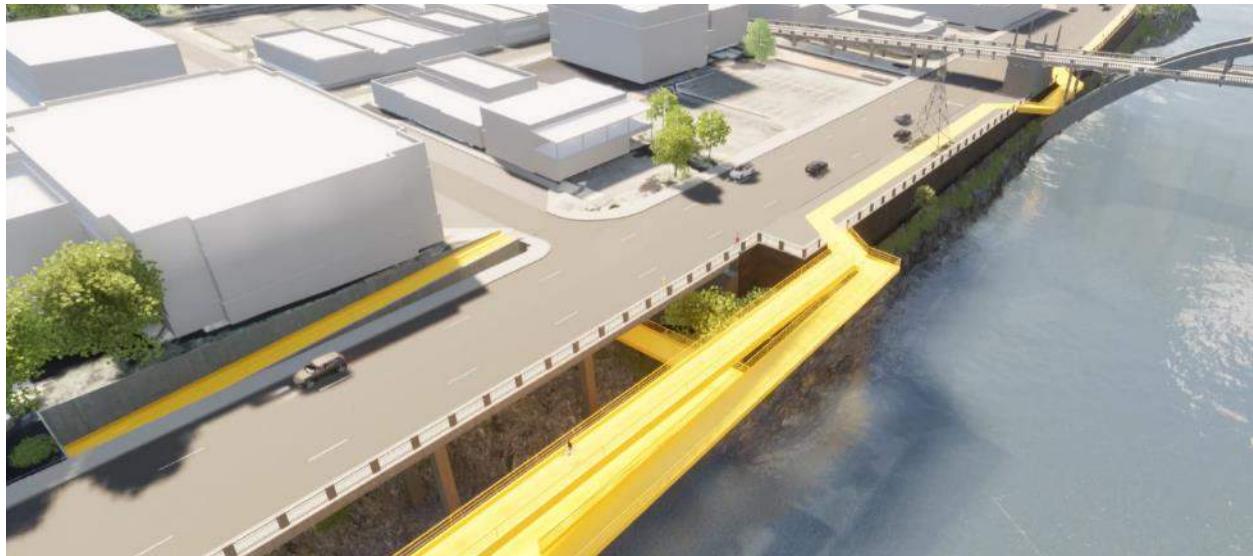
path ties back to McLoughlin Boulevard right-of-way and runs along the seawall connecting to the planned open space and tumwata village development. Figure 3 illustrates the conceptual rendering for Alternative 1B: High Route (North Tie-In) and Figure 4 illustrates the conceptual alignment as an aerial view.

**Figure 3. Alternative 1D: High Route (North Tie-In) Concept Design**

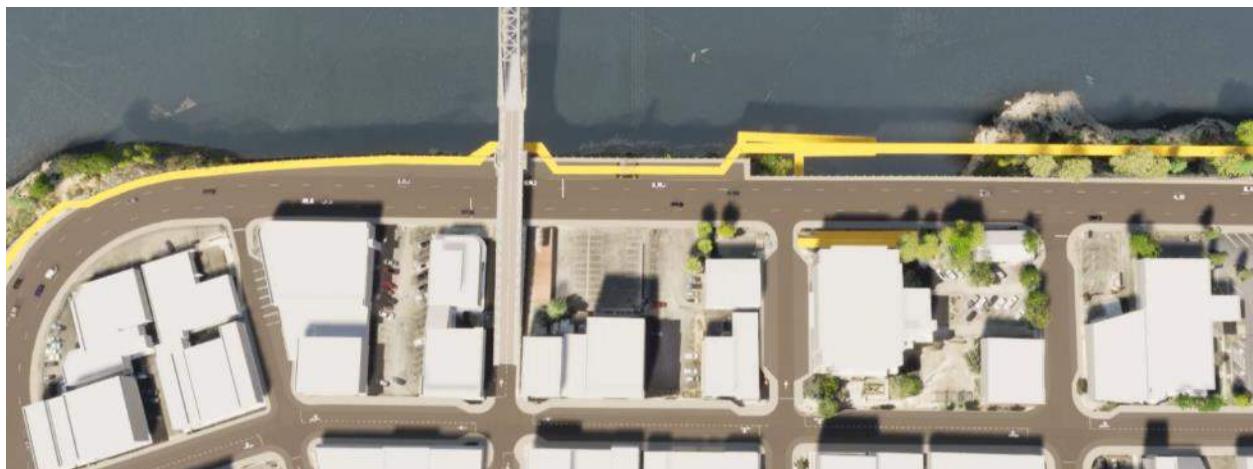
**Figure 4. Alternative 1D: High Route (North Tie-In) Alignment**

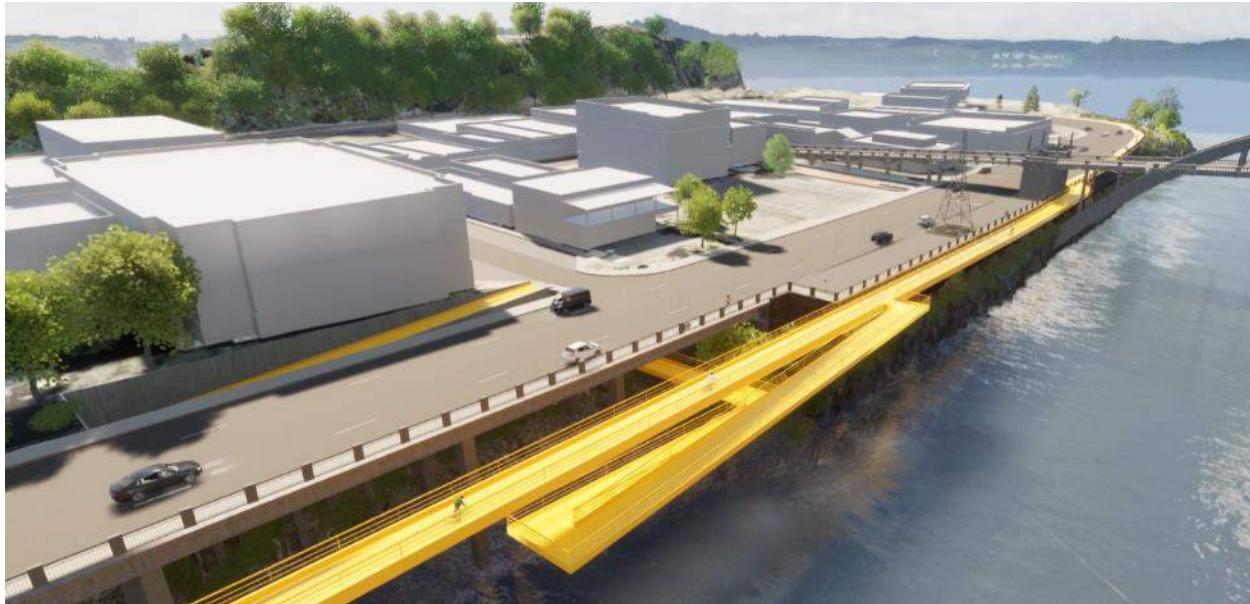
Figure 5 illustrates the conceptual rendering for Alternative 1E: High Route (South Tie-In) and Figure 6 illustrates the conceptual alignment as an aerial view.

**Figure 5. Alternative 1E: High Route (South Tie-In) Concept Design**

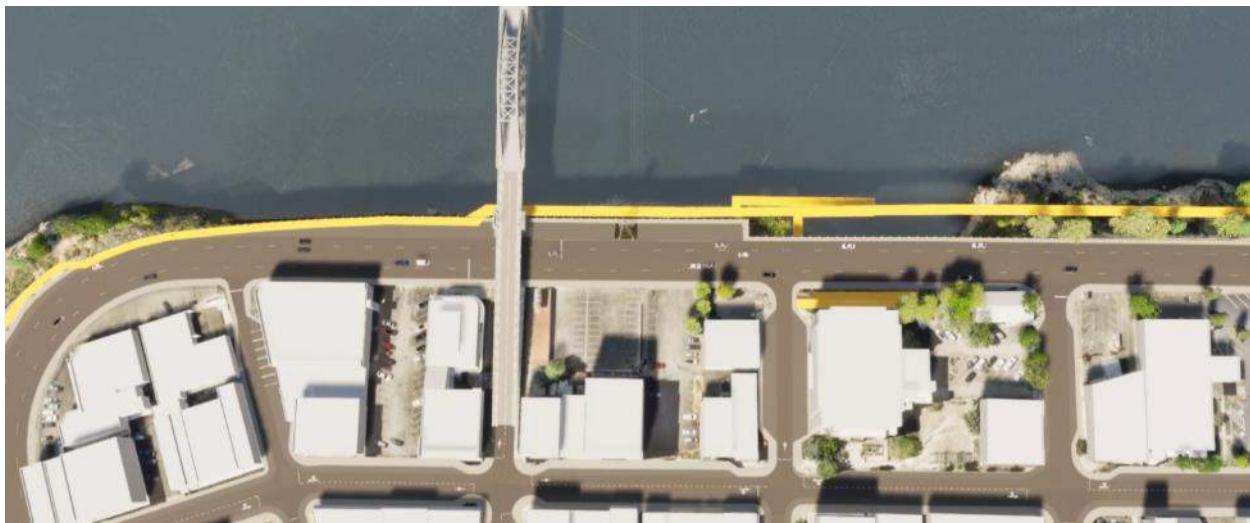
**Figure 6. Alternative 1E: High Route (South Tie-In) Alignment**

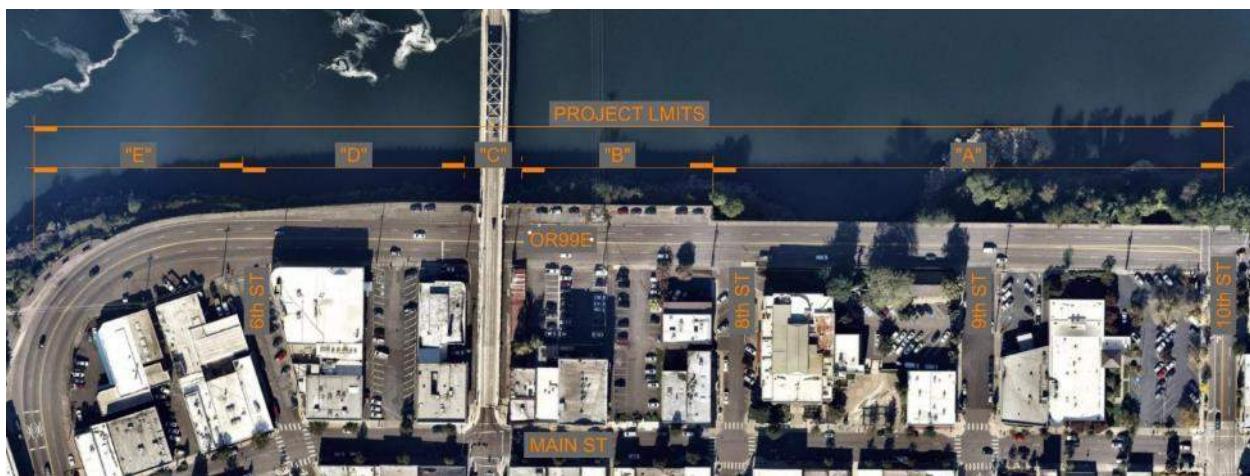
Focused on the initial three most promising alternatives previously described, the project team evaluated the alignments to determine conceptual structural viability to support solutions by considering aspects ranging from ground support to span options. The third mile long project site is comprised of a wide range of physical constraints and boundary conditions which directly influence opportunity for viable superstructure and substructure solutions. These portions are as summarized Table 1 and descriptions of the segments shown in Figure 7.

**Figure 7. Alignment Segments**

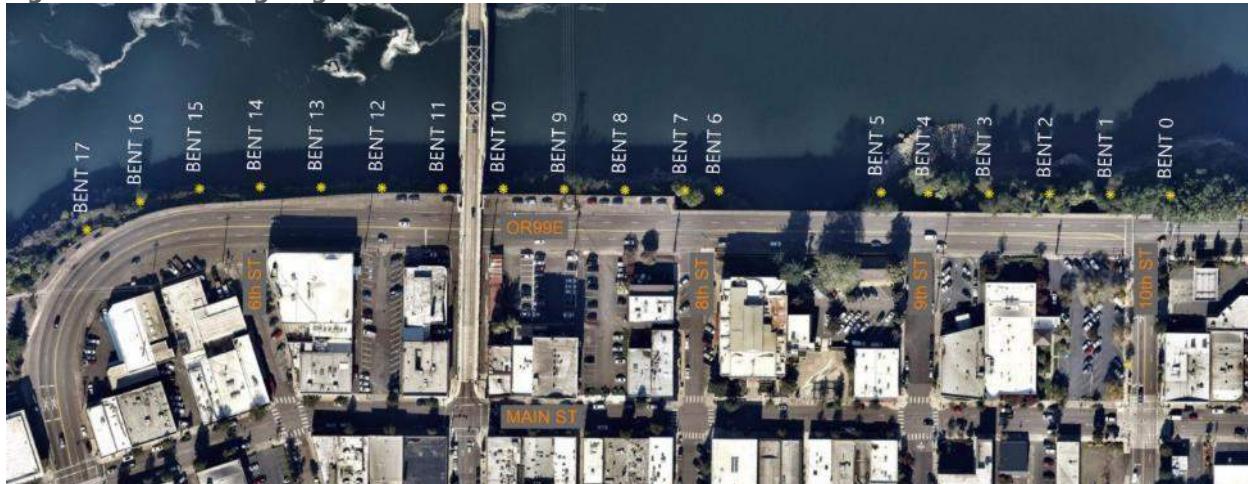
The project team evaluated the possible foundation locations and geotechnical conditions for all three of the initial most promising alternatives. As shown in Figure 8, 18 bents were identified as locations for footings based upon conventional conceptual span arrangements that could provide cost-effective and constructible concrete girder solutions for the initial most promising alignment supports.

**Figure 8. Bents along Alignment**

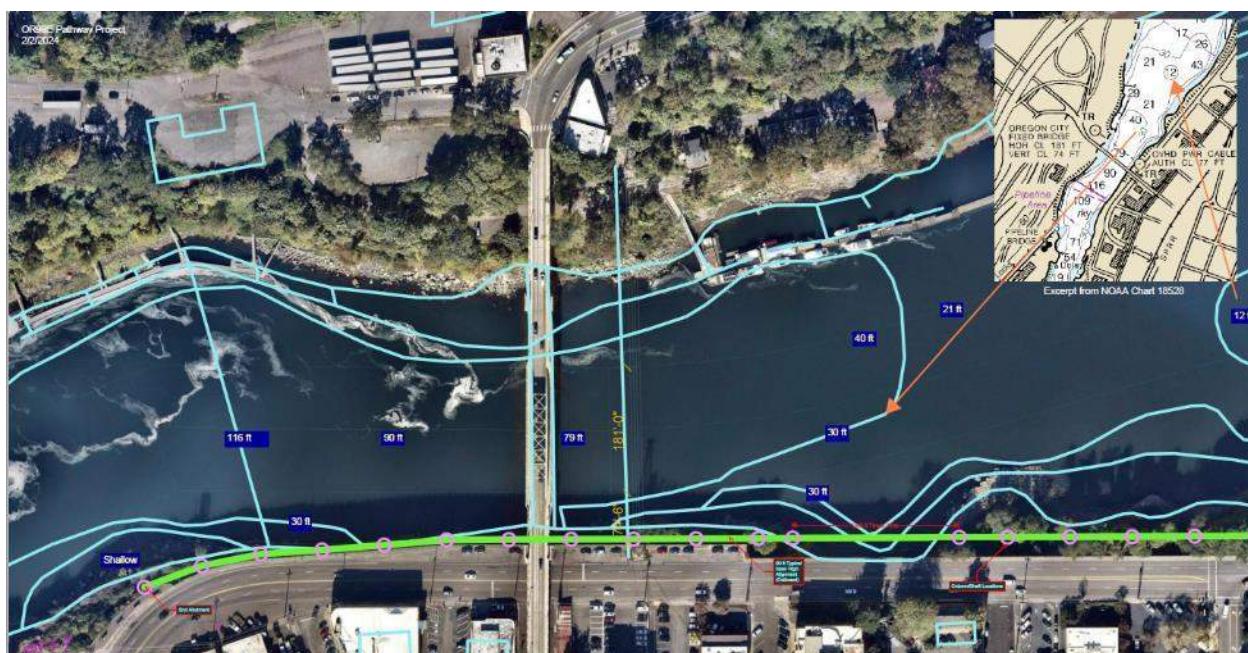
A geotechnical analysis and review of the publicly available ground and bathymetric conditions, shown in Figure 9, indicated that there was little to no opportunity for external foundation support between Bent 11 and Bent 15. This finding was due to the practical lack of available ground, steep vertical rock surfaces, and a steep ground drop off at the base of the seawall extending below water where depths extend up to 90 feet.

## Figure 9. Ground and Bathymetric Conditions

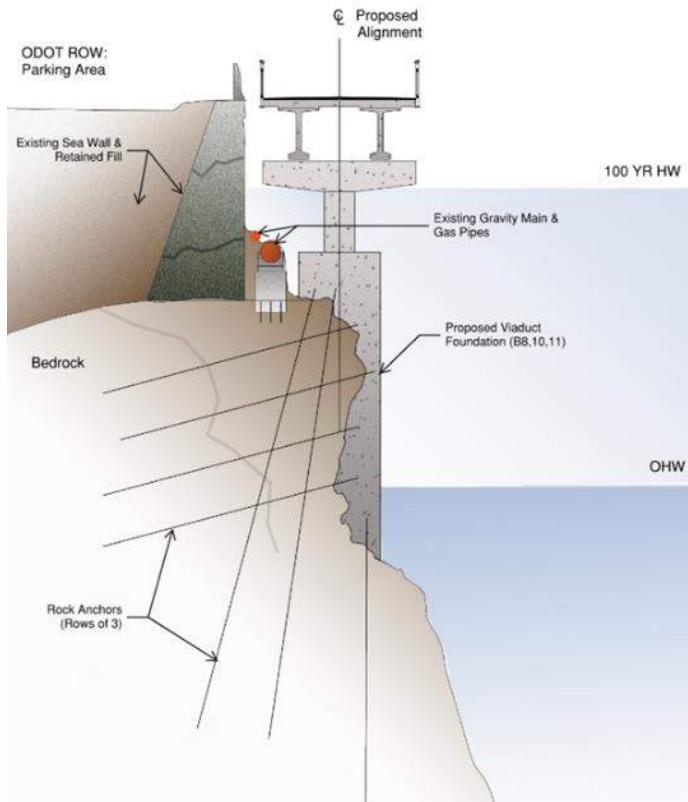
The availability for foundations in the vicinity of the arch is extremely limited and a minimum structural span of at least 90 feet is required to connect available rock outcroppings adjacent to the existing arch piers. South of the existing arch, it was determined that there could be a unique opportunity for a foundation support at Bent 11 which could be feasibly accommodated by drilling and anchoring into the rock face below the front face of the seawall as shown in Figure 10.

**Figure 10. Typical Foundation with Rock Anchorage**

It was determined that foundations and structural supports in the vicinity of the existing arch bridge would require extensive vertical and horizontal anchorage to provide adequate support to the rock face while improving the rock layer's stability. This approach could be conceptually achieved with rock anchors drilled and anchored into the rock outcropping below the existing seawall. The concept shown in Figure 10 for Bent 11 would also apply at Bent 10 and Bent 8, whereas other locations could employ more typical vertical bearing-type footings assuming excavated rock benches and micropiled footings were constructed. All external footings would require vertical micropiles in addition to horizontal rock anchorages to resist both lateral seismic forces and overturning demands.

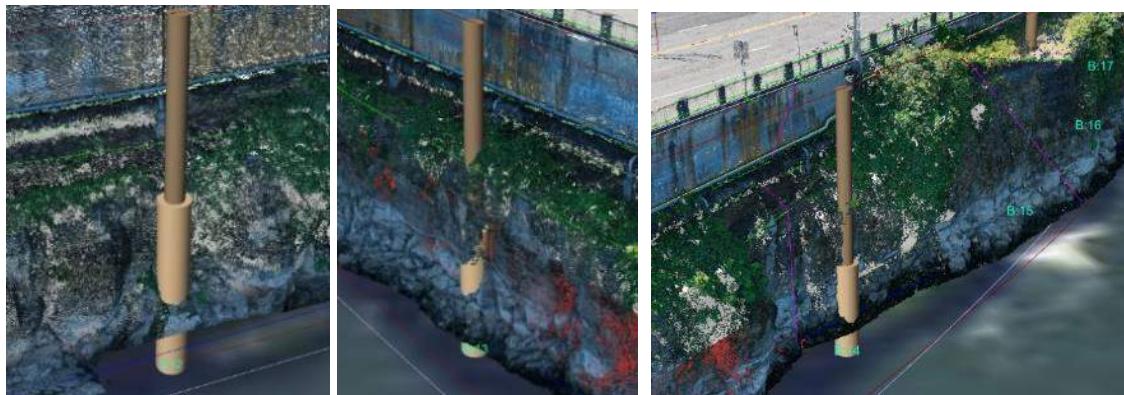
Anticipated ground-support constructability challenges and risks associated with the majority of the 18 foundations would require complicated structural solutions which may have limited construction timing windows (i.e. in-water work) to construct them as well as requirements to meet permitting requirements and lead times. As seen in Figure 11 which provide a visual of potential footing locations superimposed on the LiDAR point cloud data, Bents 12 to 14 would not be able to viably support a footing, requiring alternate conceptual solutions to structural address this gap, and could involve longer spans or a cantilevered solutions extending out over the existing seawall, in order to complete this portion of any alignment following potential foundation support at Bent 11.

**Figure 11. Challenges for Foundation Construction**

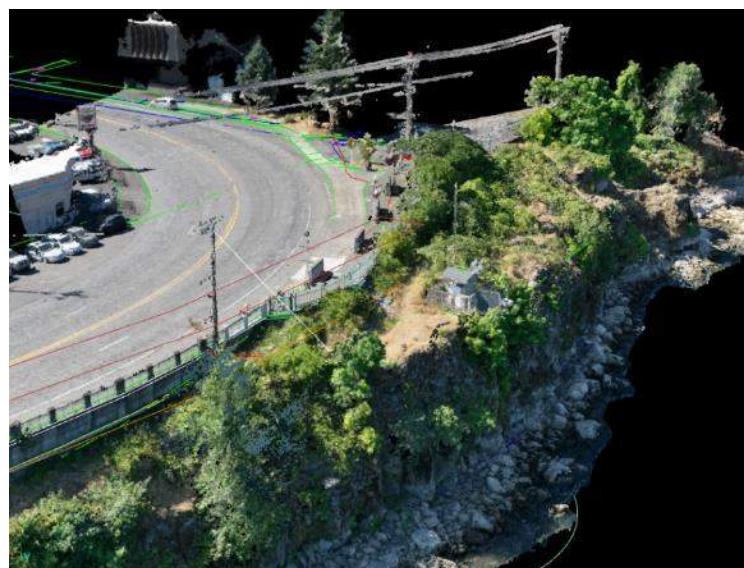
The availability of ground for foundations and structural supports south of Bent 11 becomes available near Bent 15, or approximately, where McLoughlin Boulevard curves eastward and as the existing ground and rock outcropping extends away from the seawall at this location. As shown in the LiDAR point cloud data isometric view in Figure 12, the availability of exposed rock on higher ground provides significantly more accessible and favorable constructability conditions at this location, and consequently, less risk for foundations options assuming that conceptual structural span options can leverage this availability.

**Figure 12. Possible Bent Location**

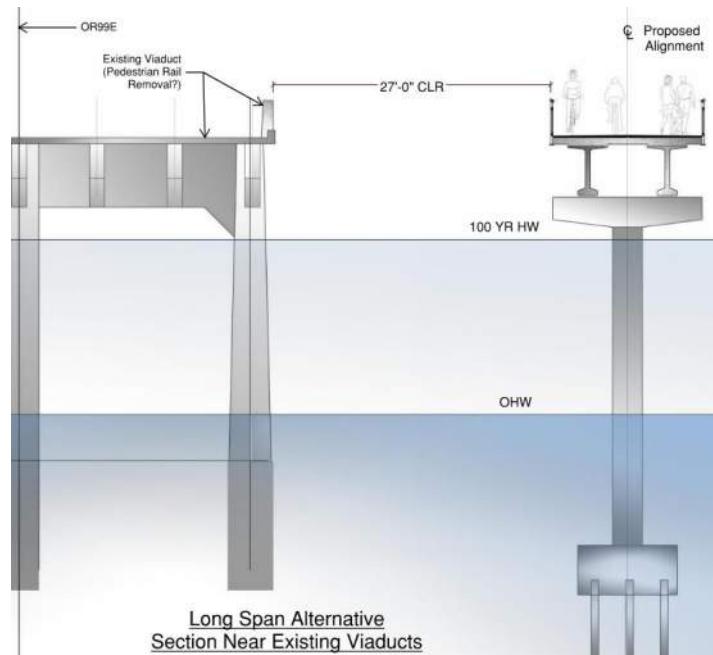
- a. Consisting of a concrete deck supported by ODOT Standard BT60 girders as shown in Figure 13.
- b. Span lengths similar to steel alternative (50 ft. to 90 ft.) utilizing BT60 girders for most spans and between the existing arc selected so that they can span between/thru the existing arch while also providing the required vertical clearance through the arch.
- c. A concrete superstructure provides improved ease of construction and is a familiar solution for bridges in the Pacific Northwest.
- d. Substructures consisting of single column bents on concrete footings supported by micropiles and rock anchors. Some foundation locations are challenging because of limited support area which require lateral anchorage to the existing slope.
- e. This variation provides the highest weight and results in a higher seismic demand.

**Figure 13. Typical External Viaduct Cross Section**

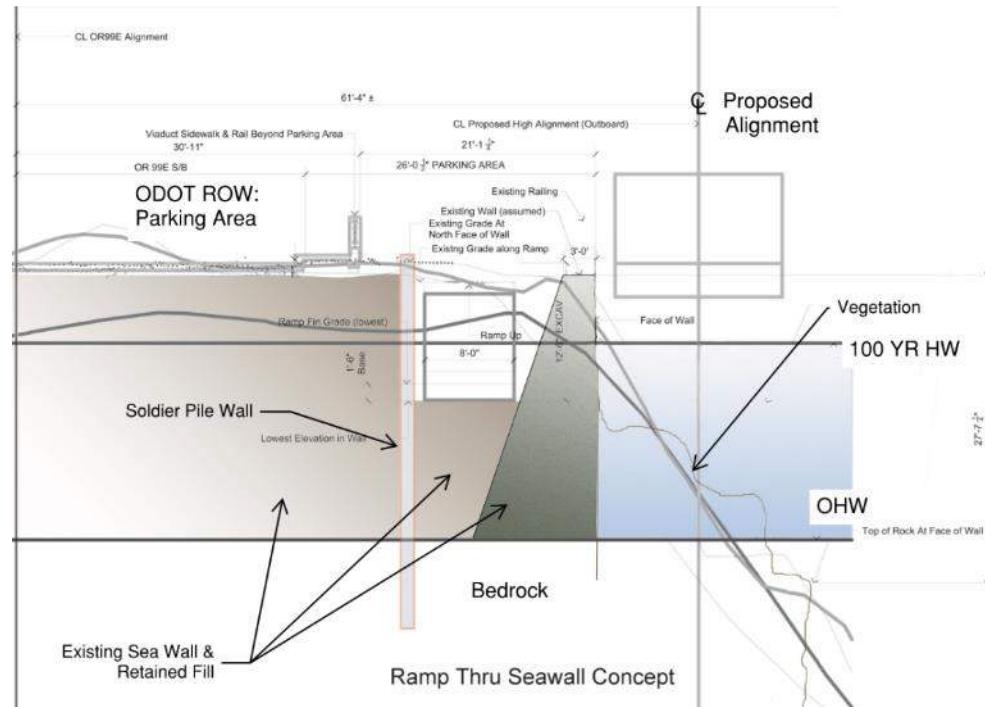
- a. A lightweight steel deck supported on steel bents as shown in to provide external support where the availability of outboard ground support was not possible (i.e. between Bent 11 and 15)

**Figure 14. Typical Seawall Cantilever Cross Section**

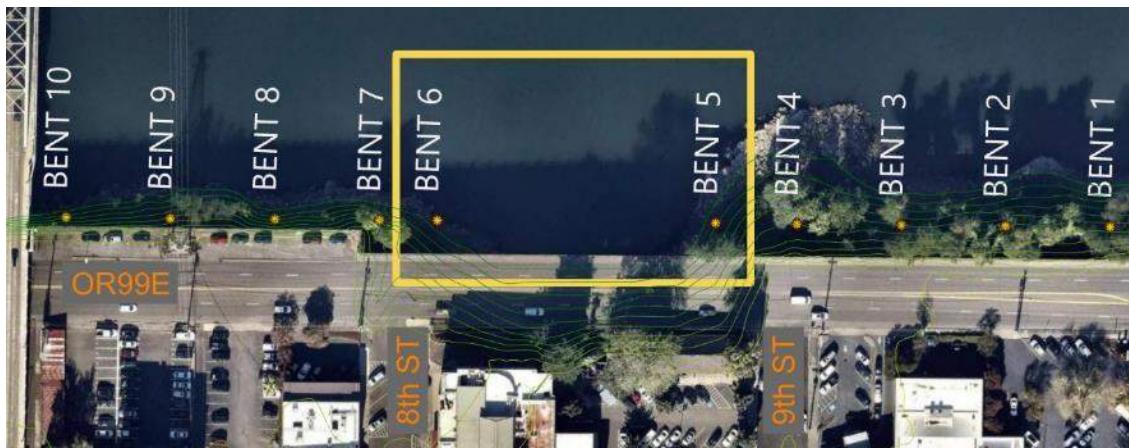
At a section of the alignment located between 8<sup>th</sup> Street and 9<sup>th</sup> Street and as shown in Figure 15, the alignment posed challenges for foundation construction in the river. The longer span elements of the existing viaducts span an area considered to be an original natural river channel and produces a ground profile that presents challenges for providing viable foundation supports without more detailed bathymetric and hydraulic data. To provide a conservative conceptual structural span solution given the lack of available ground information and based upon what is available, a 240 ft long span spandrel arch with foundations connecting locations denoted Bent 5 and Bent 6 as shown in Figure 15 would be viable. This structural concept is illustrated in Figure 16 as an isometric sketch in the LiDAR point cloud data model.

**Figure 15. Foundation Limitations/Challenges Between Bent 5 and 6 (9<sup>th</sup> Street to 8<sup>th</sup> Street)**

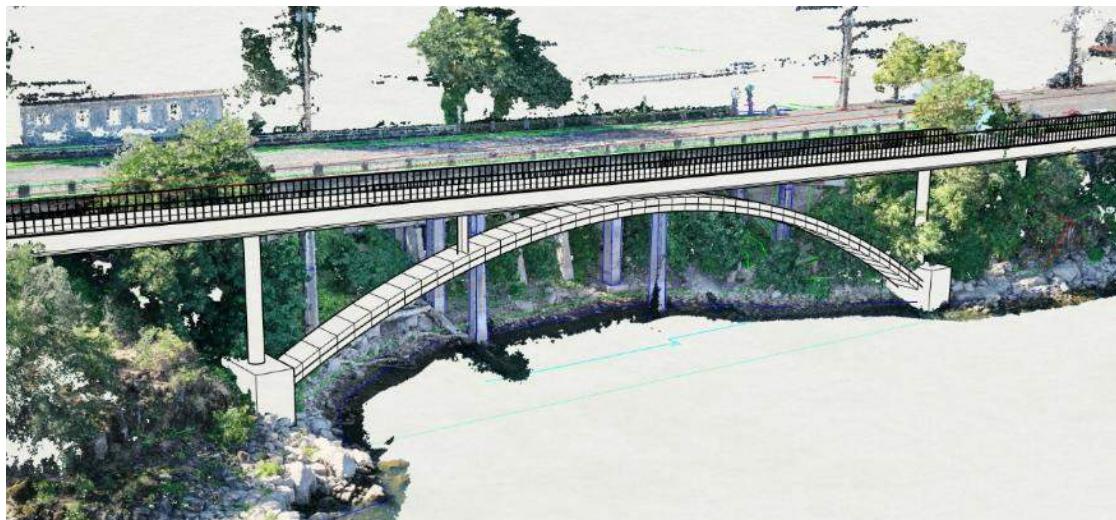
The longer span spandrel arch concept integrates conventional BT-60 girders and concrete decking similar to the conventional span structures described previously while being supported by a longer span concrete arch rib located below the deck. The arch rib would have a typical rise to span ration of 15% and provide supports to deck at quarter points, producing thrust at the foundations which would be resisted by foundations anchored into the rock.

**Figure 16. Spandrel Arch Concept View**

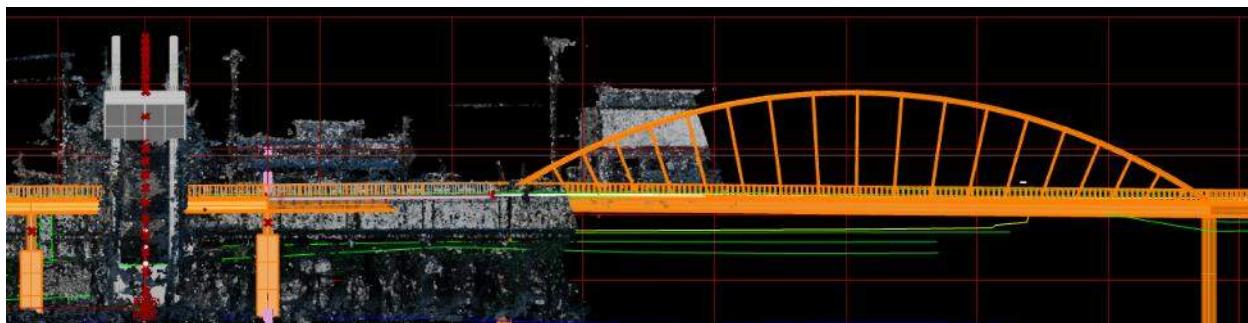
The steel arch would provide an above-the-deck structure to minimize deck structural depth and provide the least impact to grade changes of the alignment in order to traverse this portion of the most promising alignment.

**Figure 17. Long Span Steel Arch Concept South of the Existing Arch**

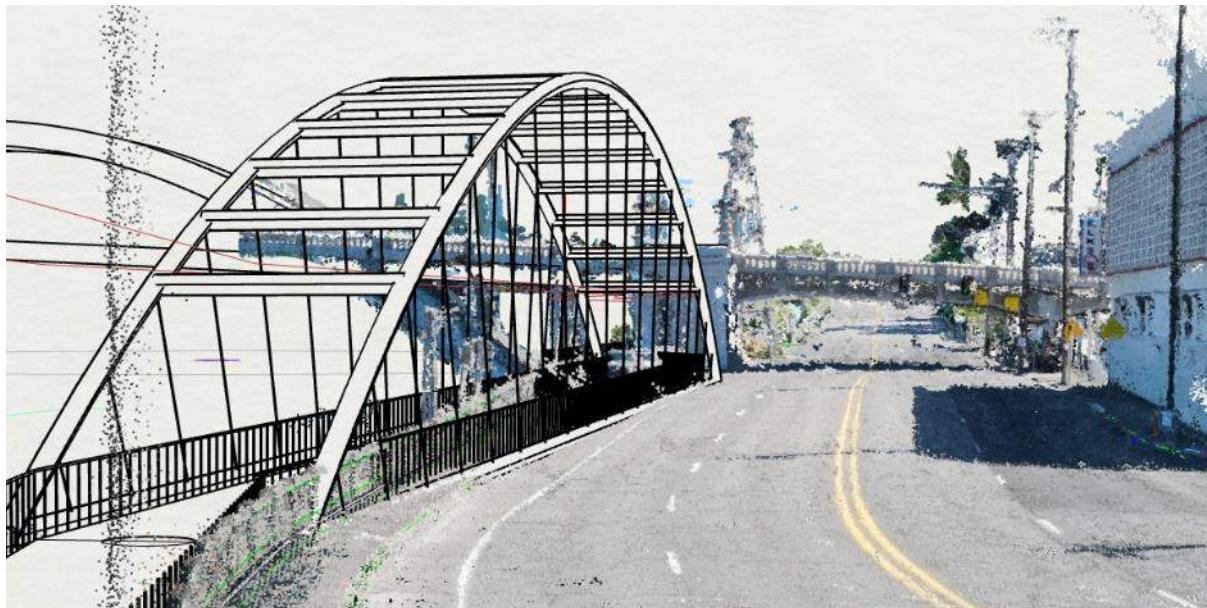
**Figure 18. Steel Arch Isometric View**

To meet the requirements to complete a portion of the most promising alignments where the availability of external ground support does not exist, a longer span option could be required to span between available foundation support near Bent 11 and Bent 15. In particular, this conceptual structural support alignment variation (see elevation view in Figure 17) was considered structurally viable and would consist of a long span steel tied arch as shown in Figure 18.

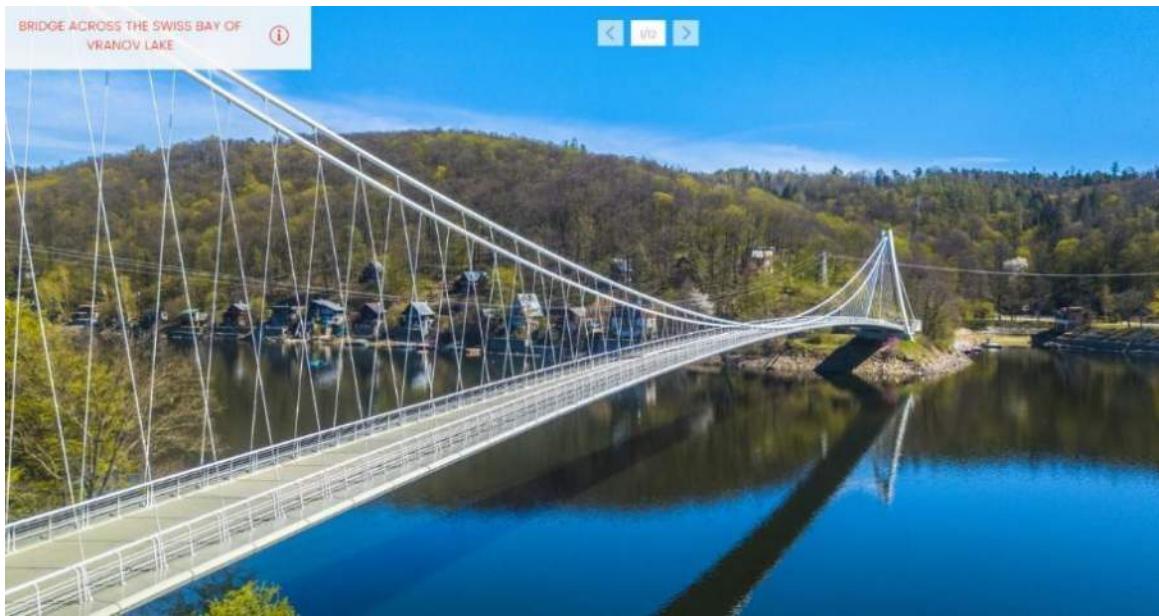
A cable-supported, suspended-style structure like the one shown in Figure 19 could provide a structural support concept that may be able to efficiently and effectively traverse these difficult conditions and leverages the location of improved ground conditions that were identified at either end of the alignment.

**Figure 19. Example of a Cable-Supported Structure**

Vranov Lake Suspension Bridge, Source: SHP

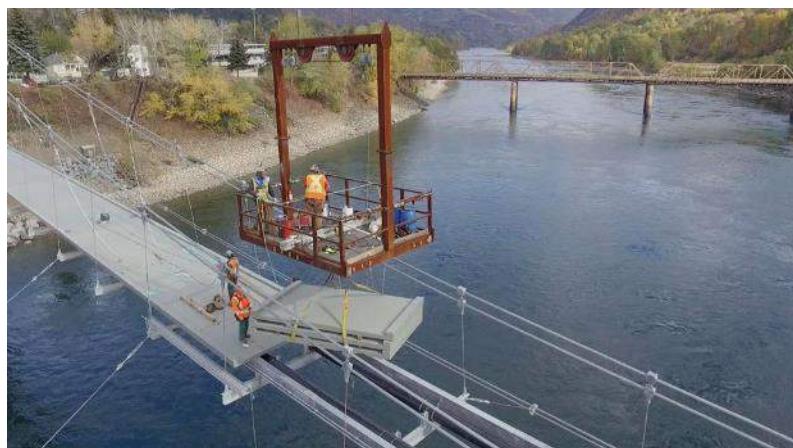
and minimize in-water and permitting risks. With significantly fewer foundation locations, the opportunity for cultural or archeological impacts is also significantly minimized. Figure 20 shows how a temporary connection between the bridge's towers (a high line) may provide construction access that avoids the need for a temporary bridge, designated traffic lane access on adjacent roadways, or access in the waterway. This approach would need to be checked for the project site conditions taking into account the clearance envelope of the existing arch bridge's vehicular traffic and understanding all adjacent impacts from overhead utilities.

**Figure 20. Construction Access Between Bridge Towers**

Columbia River Skywalk, Source: Coastline Composites

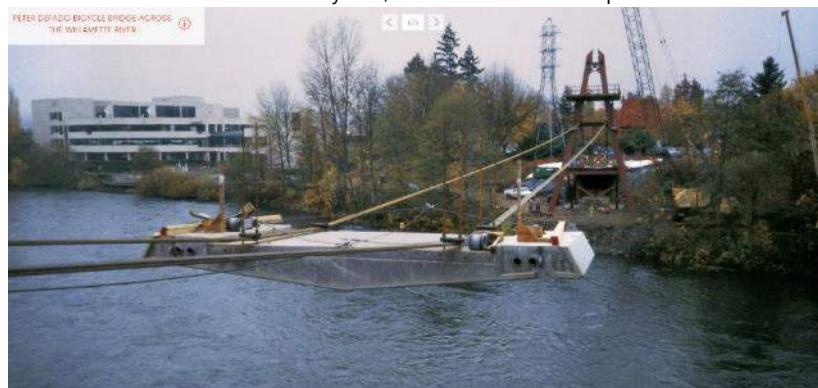
Willamette River Bridge Construction, Eugene, Oregon, Source: SHP

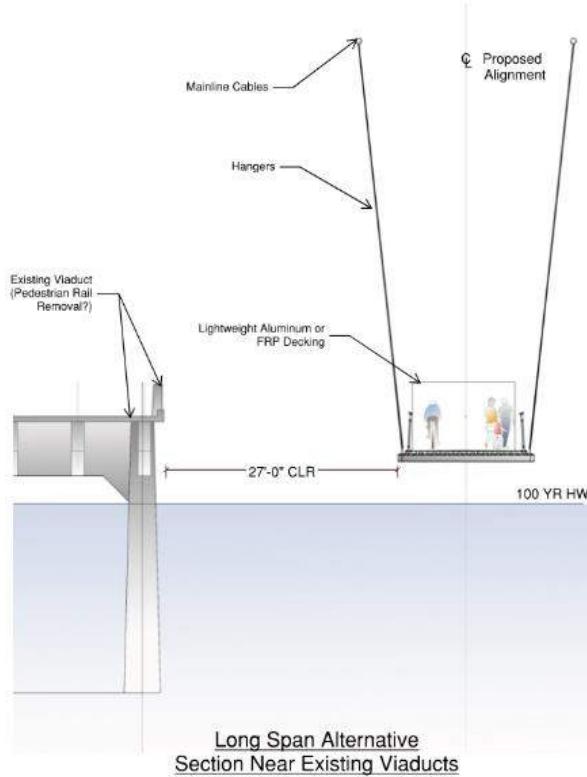
**Figure 22. Long Span Section**

By leveraging the benefits of the cable-supported suspension bridge mainline sag at midspan, the bridge's support structure drops to a minimal level at midspan to provide adequate clearance and passage through the existing arch bridge without requiring additional foundations for support: In effect, a very low profile structural producing minimal visual impact to the existing arch and seawall while avoiding foundation impacts to the adjacent utilities and the existing seawall due to clear separation between the structures as seen in Figure 22.

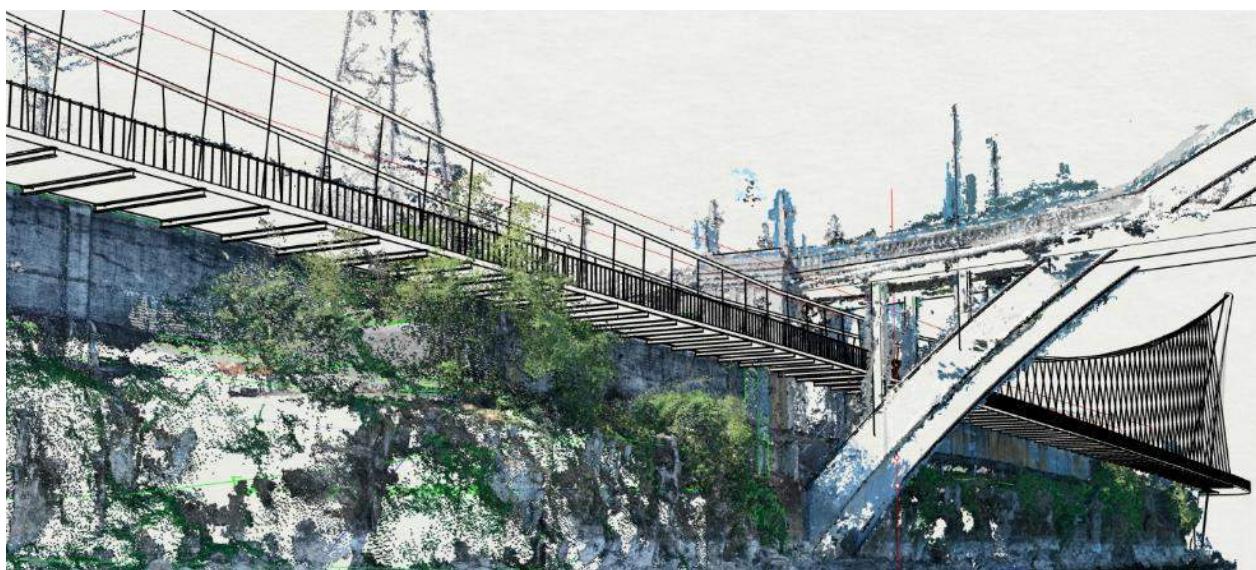
**Figure 23. 1B Long Span Variation**

As viewed in Figure 23, the structure efficiently passes through the existing arch bridge and under the overhead catenary utility lines with foundations that are the farthest possible location from these existing structures. The risks of a long span bridge can be managed through design and construction utilizing expertise and would eliminate many of the unknowns associated with excavation on or near the existing arch bridge and the seawall.

The effectiveness of the long span solution is evident from its minimal foundation footprint. The conceptual long span solution addresses many of the site constraints imposed by the unknown structural integrity and condition of the existing seawall, effectively spanning over the issues.

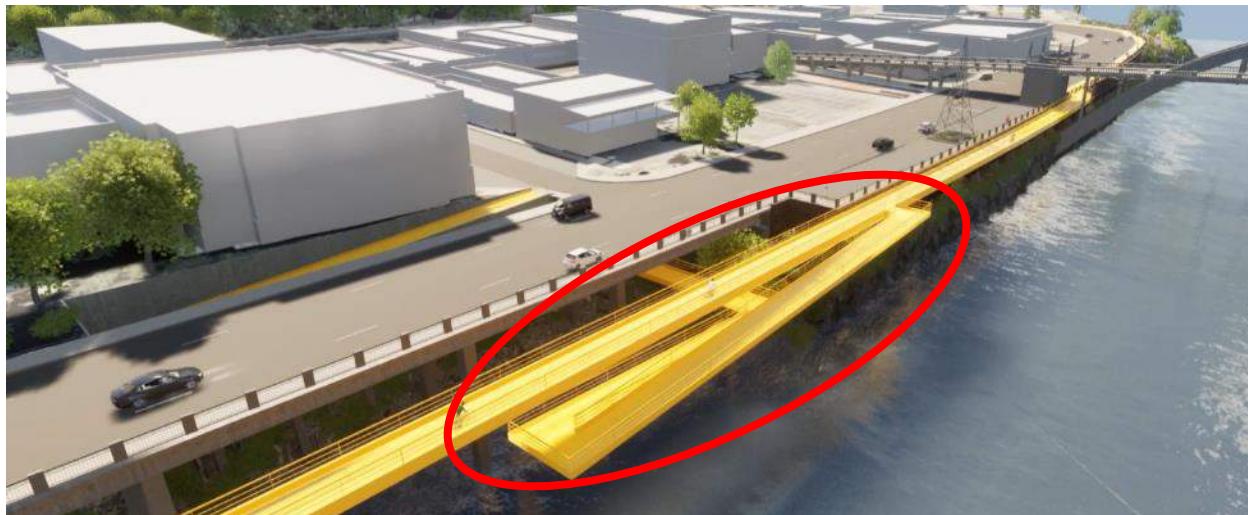
**Figure 24. 8th Street Undercrossing (Ramp Outside Shared-use Path)**

The initial undercrossing concept included a ramp that extended under McLoughlin Boulevard at 8<sup>th</sup> Street, with access provided at the location of the existing 8<sup>th</sup> Street stairwell. The connection passed under the viaduct utilizing conventional concrete girders and foundation supports, then ramping up on the outside (river side) of the shared-use path. This concept is shown in Figure 24.

The 8<sup>th</sup> Street Undercrossing (Ramp Outside Shared-use Path) was determined infeasible and dismissed due to an inability to structurally support that westerly external ramping over the river. This location would require in-water construction with deep foundations and additional permits including the US Coast Guard.

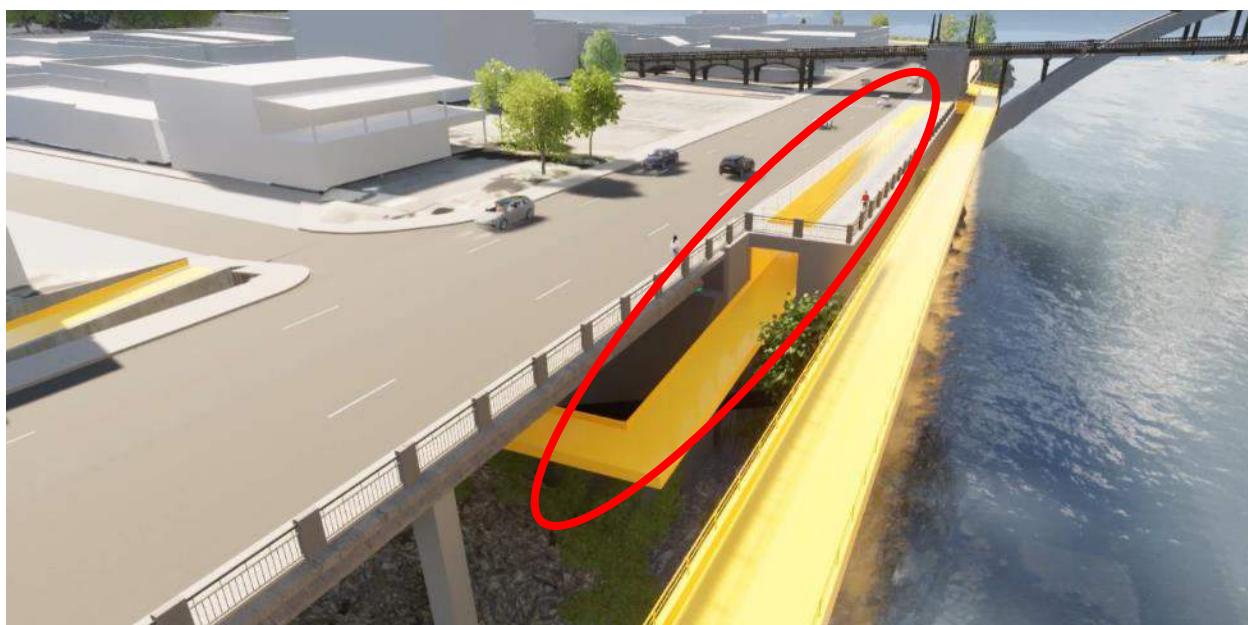
**Figure 25. 8th Street Undercrossing (Ramp Inside Shared-use Path)**

The second grade separated undercrossing concept explored included a ramping structure on the inside of the shared-use path between the shared-use path and viaduct. This concept required utilization of the existing parking area to ramp path users up to the grade of the McLoughlin Boulevard right-of-way. This concept is shown in Figure 25 and involved a soldier piled wall to support McLoughlin Boulevard while providing the opportunity for a grade separation in the fill behind the existing seawall.

This approach was also dismissed due to cultural and structural concerns in developing internal ramping within the parking area behind the seawall. Specifically, cultural concerns arise from excavation behind the wall, which might damage some cultural resources. Issues due to excavation near the wall also carry the risk of damage to the unreinforced structure, in addition to requiring modifications to the utility tower.

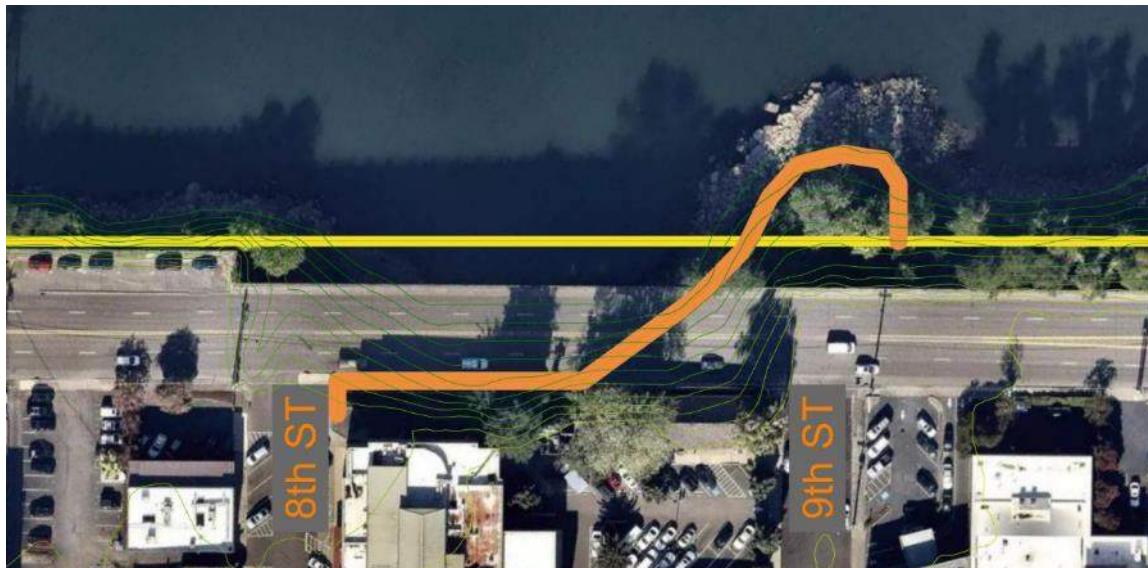
**Figure 26. 9th Street Undercrossing**

To address the issues identified in the two initial 8<sup>th</sup> Street concepts, a third approach for a grade separated undercrossing was identified utilizing a new location and tie in of the undercrossing. This third approach is being evaluated to shift the undercrossing to 9<sup>th</sup> Street. This concept would consist of an entry ramp at 8<sup>th</sup> Street (near the existing stairwell), and would then ramp down to toward 9<sup>th</sup> Street, traverse underneath McLoughlin Boulevard, and connect to the shared-use path alignment at 9<sup>th</sup> Street. A sketch of the alignment is shown in Figure 26.

<b>9<sup>th</sup> Street Undercrossing</b>	Connects near existing 8 <sup>th</sup> Street stairwell. Ramps down and passes underneath McLoughlin Boulevard near 9 <sup>th</sup> Street. Ramps up on the outside (riverside) of the shared-use path.	<ul style="list-style-type: none"> <li>- Limited ROW</li> <li>- Numerous utility elements to be traversed/passed</li> <li>- Lack of available foundation supports below the viaducts</li> <li>- Impacts to current viaduct inspection and maintenance procedures</li> <li>- Security issues</li> </ul>
<b>No-Build</b>	No connection from 8 <sup>th</sup> Street to the shared-use path.	<ul style="list-style-type: none"> <li>- Does not require any structural modification to the alignment.</li> <li>- No cost.</li> </ul>

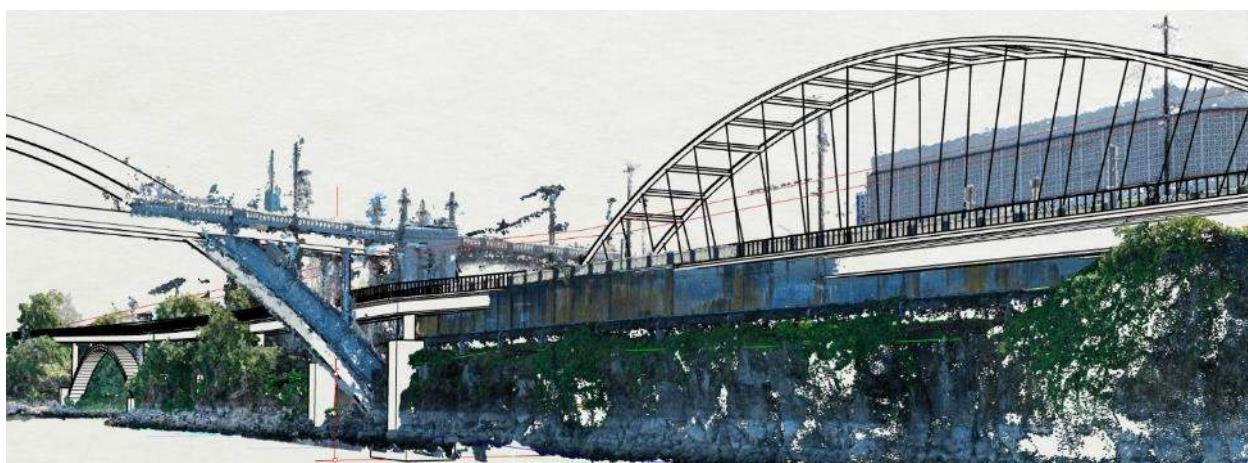
**Figure 28. 1B Viaduct Concept Looking Towards the Existing Arch Bridge**

The conventional viaduct as a conceptual structural support variation for Alternative 1B would involve an externally supported path along the viaduct section of the alignment utilizing conventional spans of about 80 to 100 feet. To traverse areas with reduced ground availability, longer fill-in spans are proposed as an approach to span these ground constraints. Between Bent 5 and 6, a 240-ft spandrel arch would provide below deck support to the alignment, while an above deck supported steel tied arch would span approximately 270 ft to span a challenging section of the alignment between Bents 11 and 15. A conventional viaduct span of approximately 90 feet would be supported on foundations adjacent to the Historic Arch Bridge and provide structural support to the alignment through openings between the existing arch bridges columns. Figure 27 provides a conceptual elevation view and Figure 28 provides a conceptual sketch view of this alignment support concept variation.

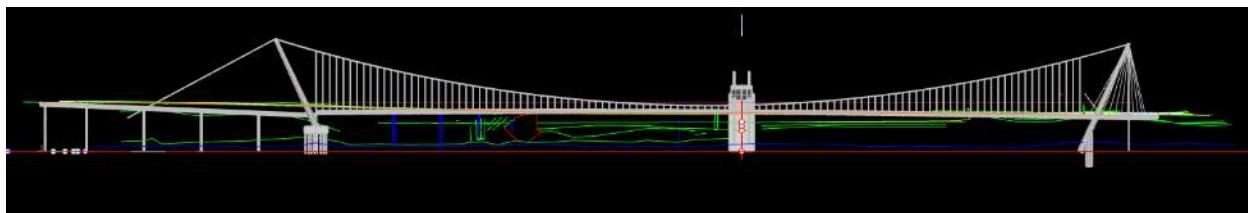
**Figure 29. Alternative 1B: Long-Span Alternative**

The long span conceptual structural support variation for Alternative 1B would involve a long span, cable supported, suspension structure. The structure would span approximately 1,250 feet and be located at

least 20 feet from the viaduct. The deck could be concrete or lightweight aluminum or FRP deck panels and could provide a minimized foundation footprint by eliminating a majority of foundation requirements and eliminating the needs for temporary supports on the ground or in the river.

During construction, the long span alternative provides advantages that minimize traffic disruption and in-water work as the suspension bridge erection methods offer unique methods which allow the work to be constructed from the mainline cables, temporary bearing cables, and/or with the use of a high-line to supply and deliver prefabricated decking panels and construction materials. Reduced construction time is an advantage especially when the necessary components are prefabricated off-site and assembled on location during a recued window of construction activities for the superstructure erection procedures.

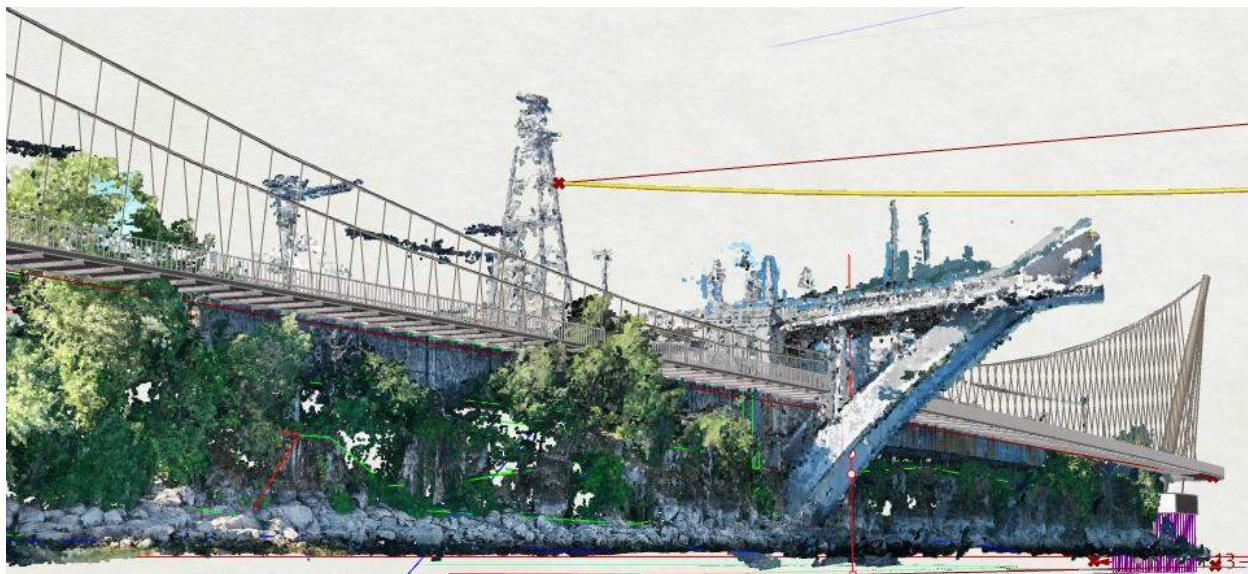
**Figure 30. 1B Long Span Concept Looking South Towards the Existing Arch Bridge**

This conceptual span would minimize impacts to the seawall by providing adequate physical separation while effectively passing through the existing arch bridge with a low impact structural solution. The long span concept ensures that major foundations are located a maximum distance from the existing arch, seawall, and utility locations. Figure 29 provides a conceptual elevation view of the alignment while Figure 30 provides an isometric sketch view of this concept as it passes through the existing arch and below the existing overhead utility catenaries to connect both ends of the project site and to fulfill the objectives of supporting the most promising Alternative 1B.
