# TECHNICAL MEMORANDUM

RE: 3.3.3B - TM#6: Most Promising Alternatives  
McLoughlin Boulevard Enhancements - 10th Street to tumwata village

## Executive Summary

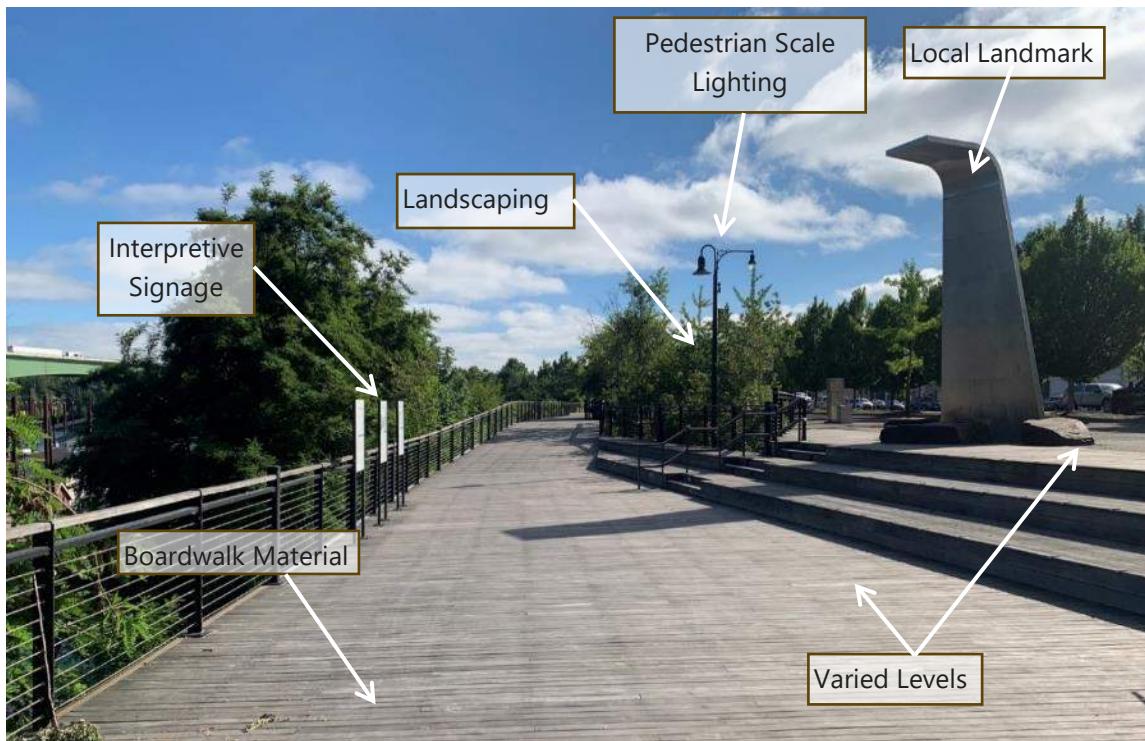
**Figure 31. Placemaking Elements for Most Promising Alternatives**

The shared-use path northeast of 10<sup>th</sup> Street has several placemaking elements that could be carried through to the new alignment. Placemaking elements from the existing shared-use path for incorporation into the most promising alternatives are illustrated and described in Figure 31. Additional placemaking opportunities are outlined in the sections below.

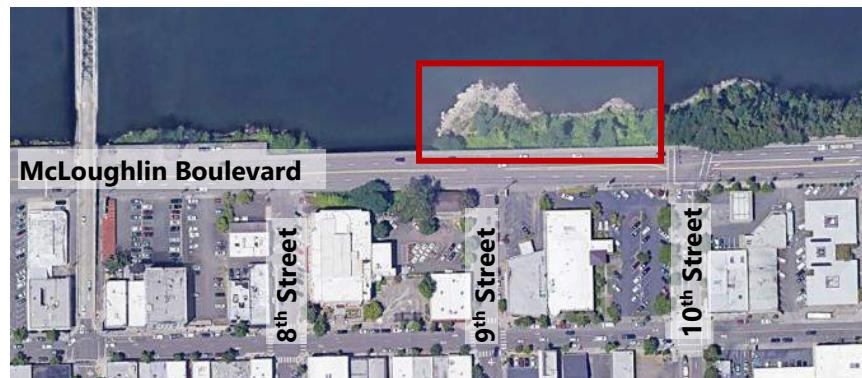
**Figure 35. Boardwalk Area**

- Footings and structural elements could be integrated into the natural topography by shaping footings to mimic rock outcroppings.
- **Boardwalk:** There is an opportunity to build a boardwalk on the rock outcropping between 9<sup>th</sup> Street and 10<sup>th</sup> Street due to the additional structural support, as shown in the red box in Figure 35. This would mean a wider shared-use path structure; the outcropping extends about 60 feet from the roadway. With a 30-foot offset, this leads to an area of about 30 feet. Therefore, this block of widened path could include increased amenities to encourage trail users to recreate, linger and enjoy views, while still providing 14 feet for travel. As discussed in later sections, the 8<sup>th</sup> Street dock could also be restored to create a hub for recreational water activities.

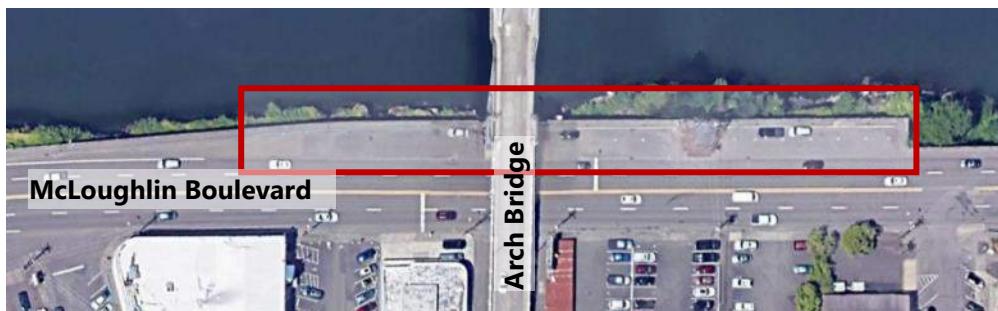
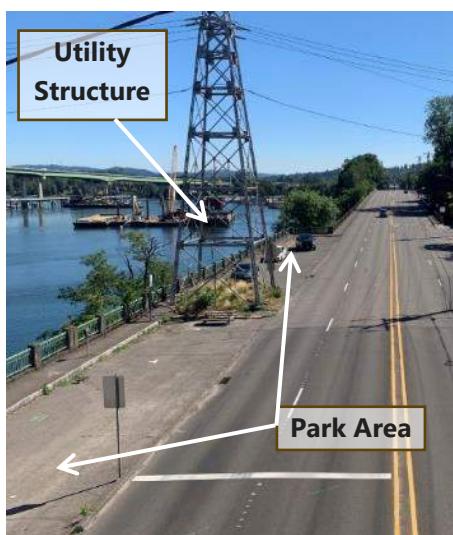
**Figure 37. Potential Park and Placemaking Opportunities**

The existing parking area along McLoughlin Boulevard between approximately 6<sup>th</sup> Street and 8<sup>th</sup> Street, shown in the red box in Figure 37, could be transformed into a green, linear park-like space. This park space would both provide a buffer for the shared-use path from McLoughlin Boulevard and create a new riverfront gathering area for Oregon City residents and tourists. Details of this opportunity for the two refined most promising alternatives are outlined in the sections below.

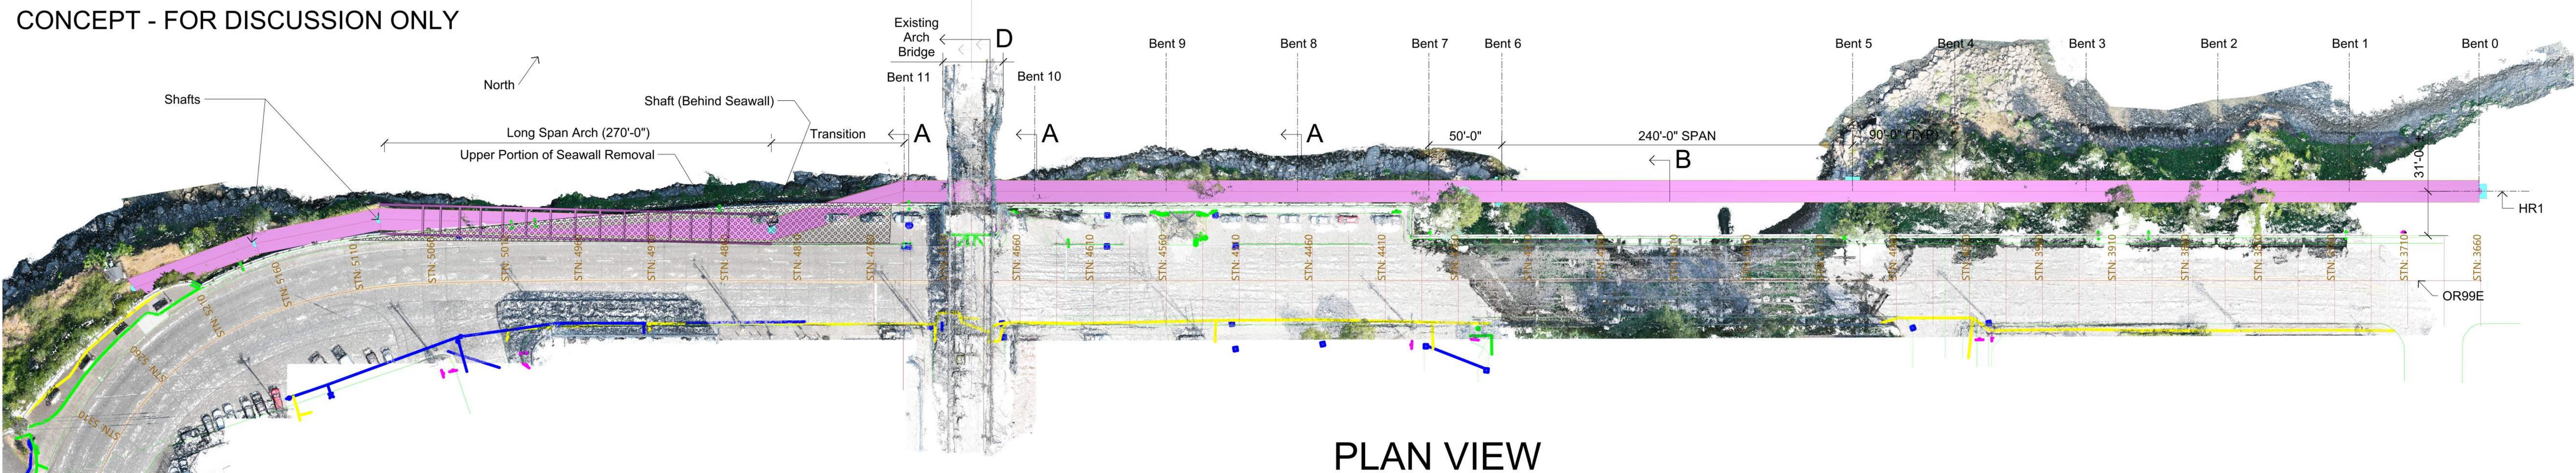
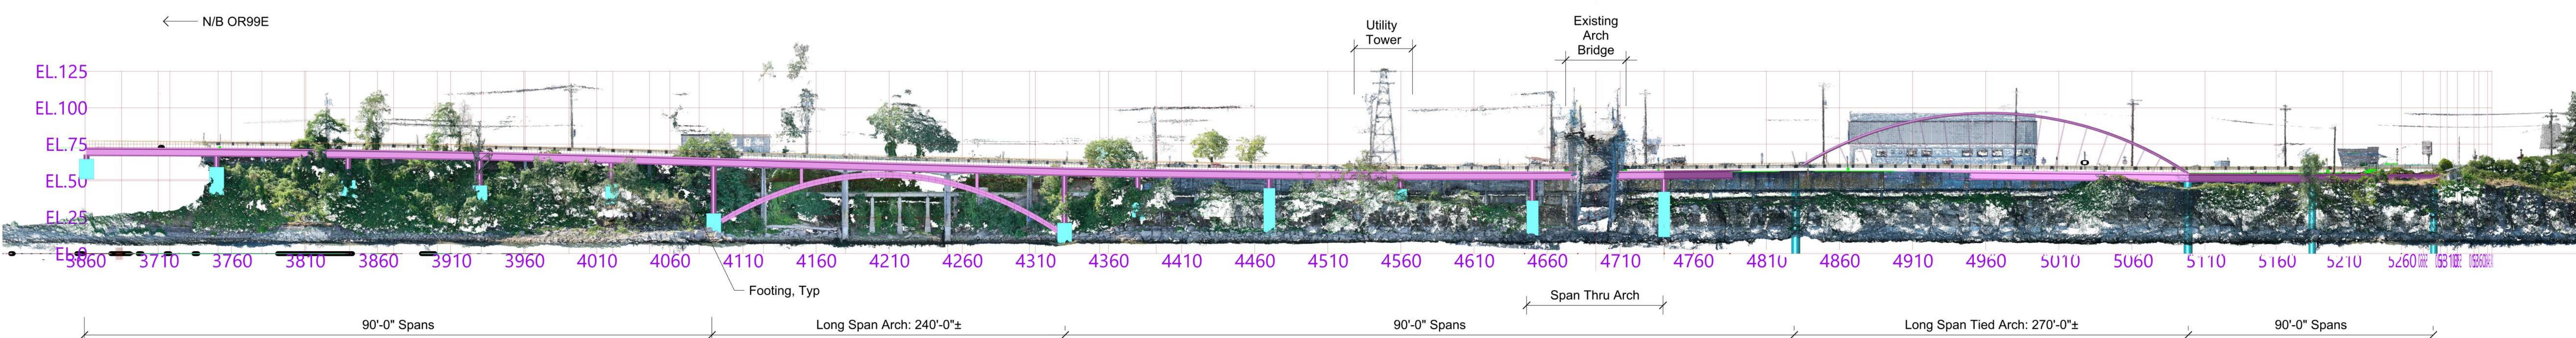
### 01-HR-S-HIGH ROUTE EXTERNAL ALIGNMENT (1,650'-0")

## PLAN VIEW

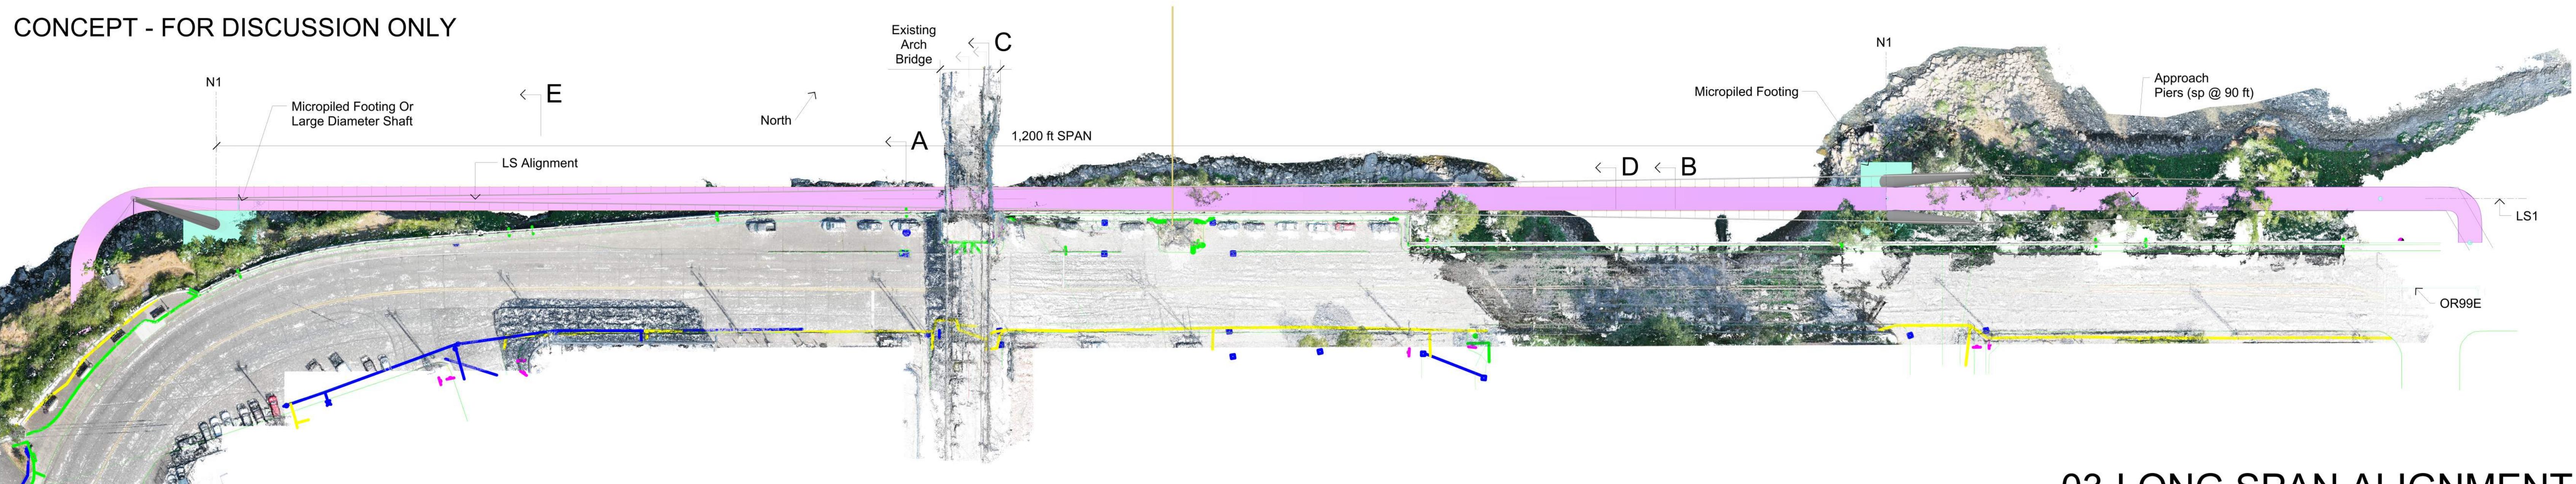
03-LONG SPAN ALIGNMENT

PLAN VIEW

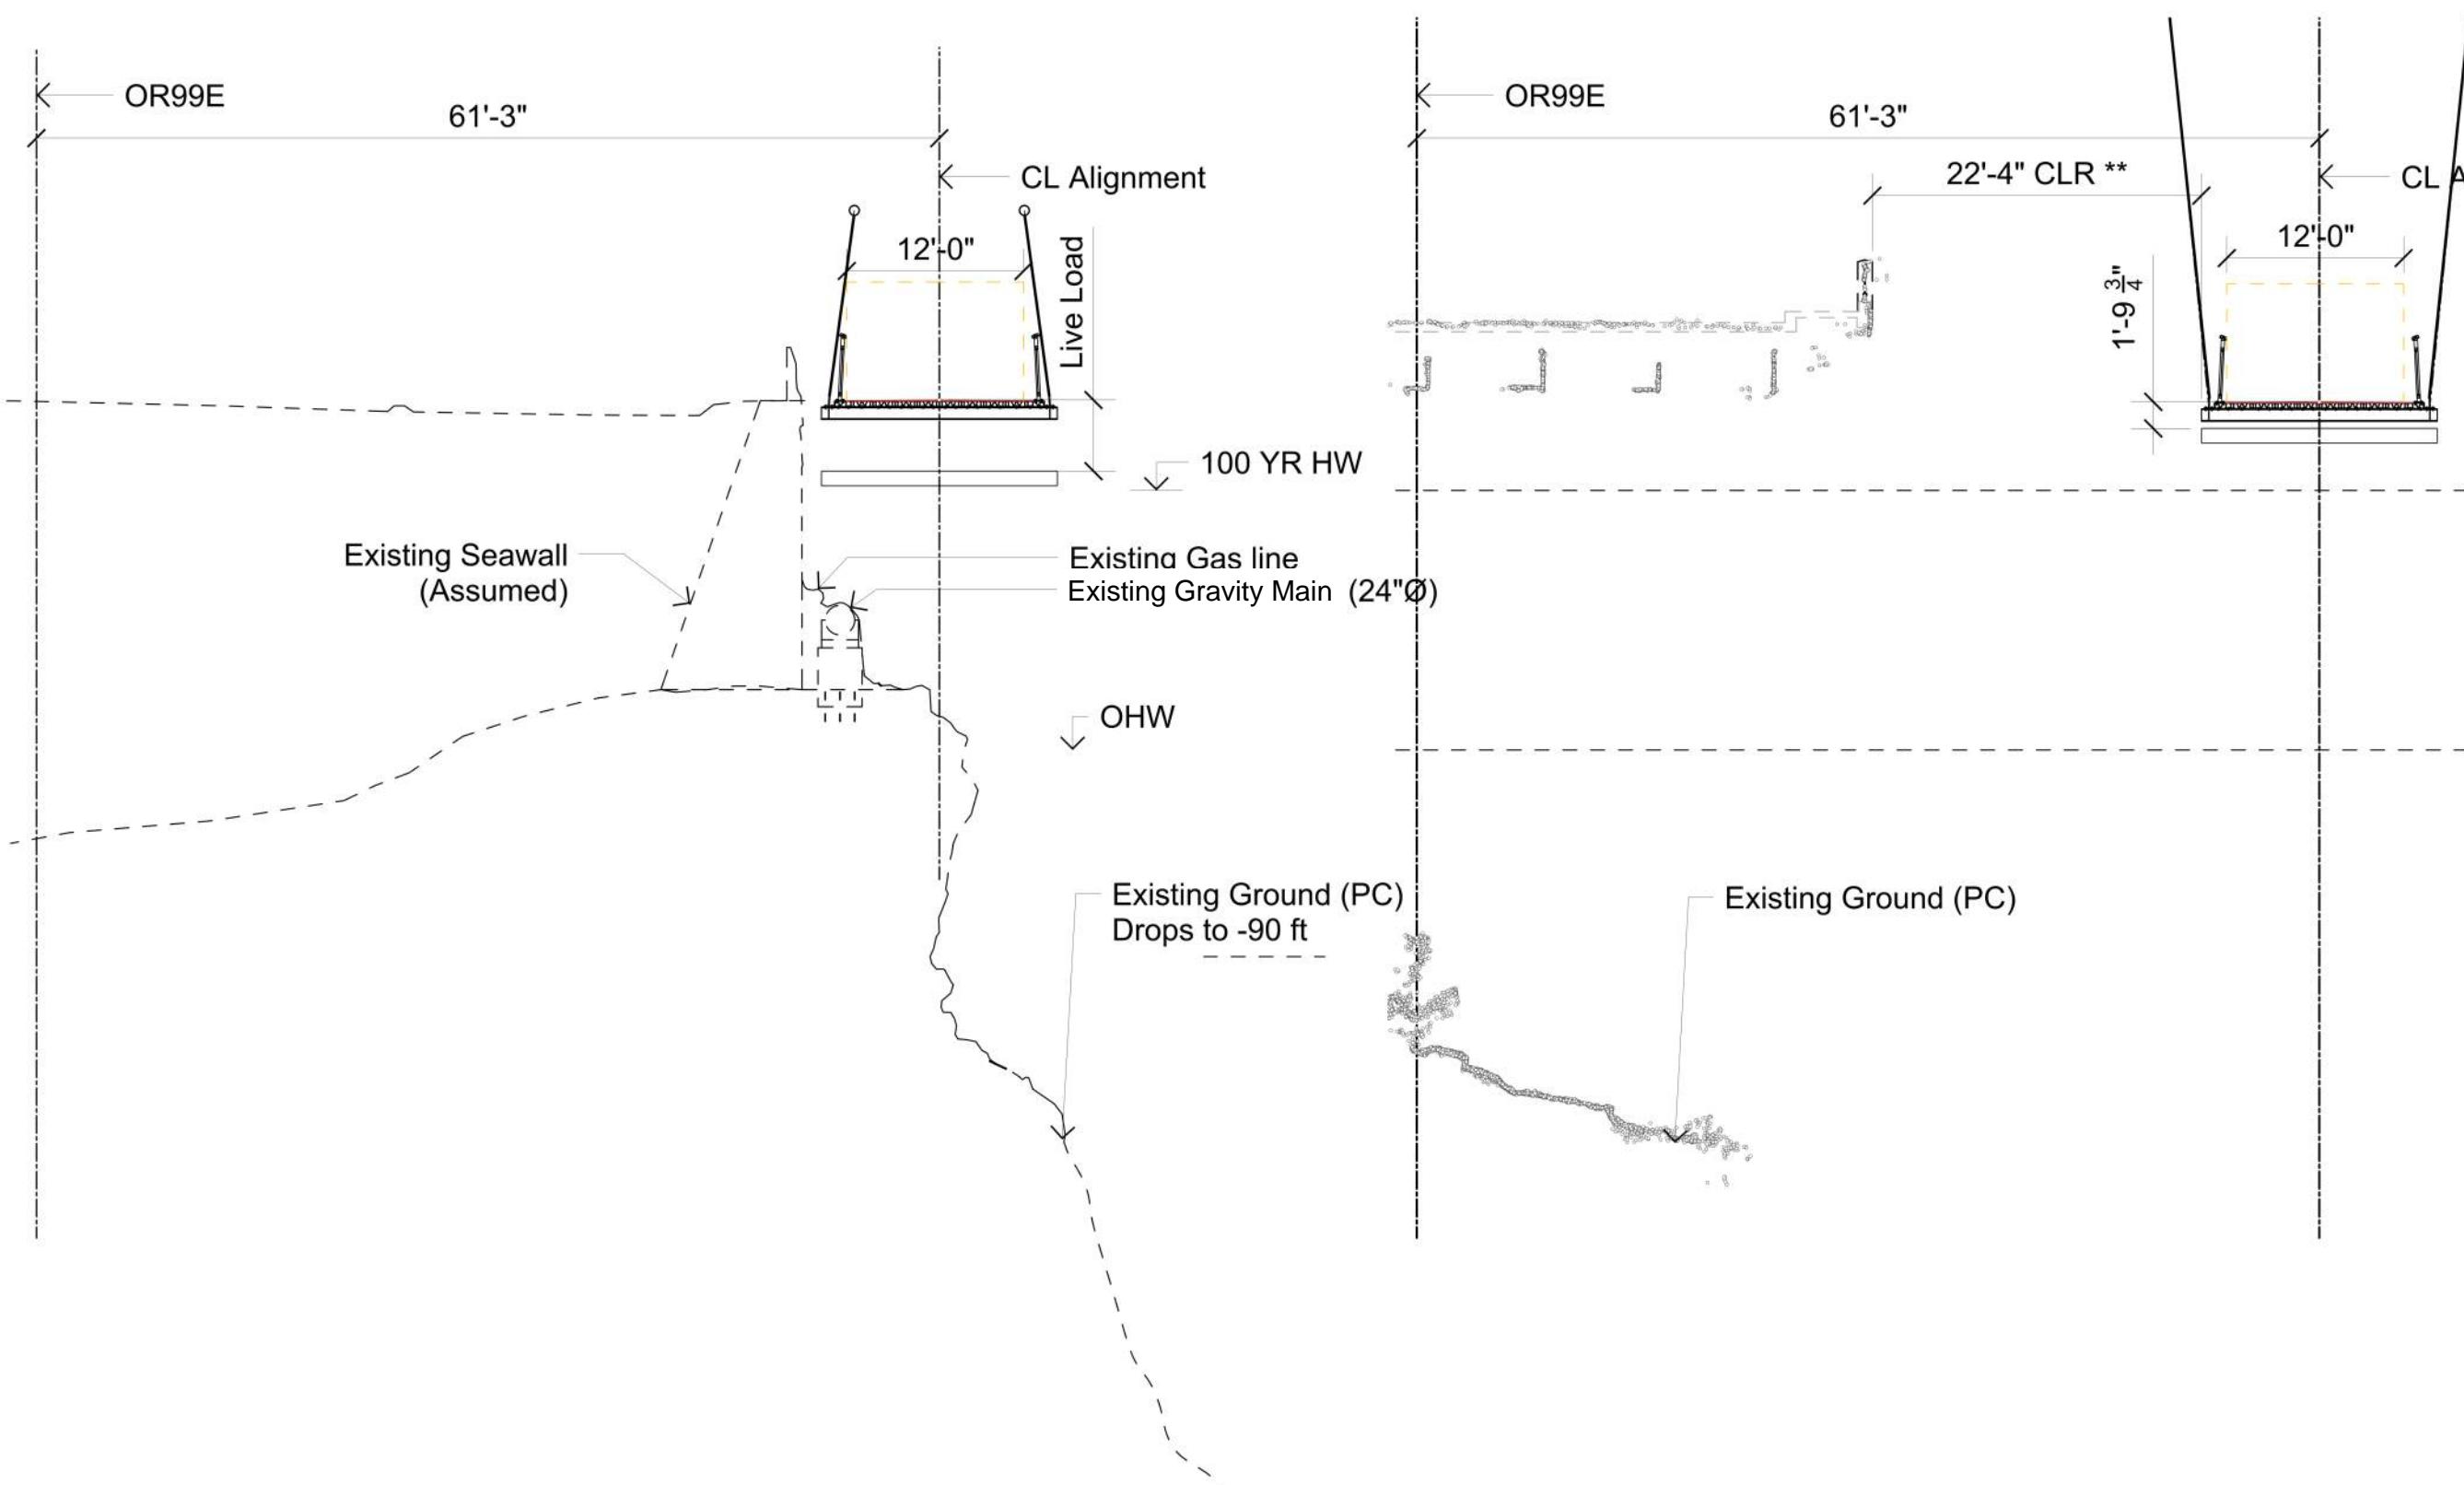
ELEVATION VIEW

A-A: Section At B10/B11 (1080)  
Scale 1"=12'-0"

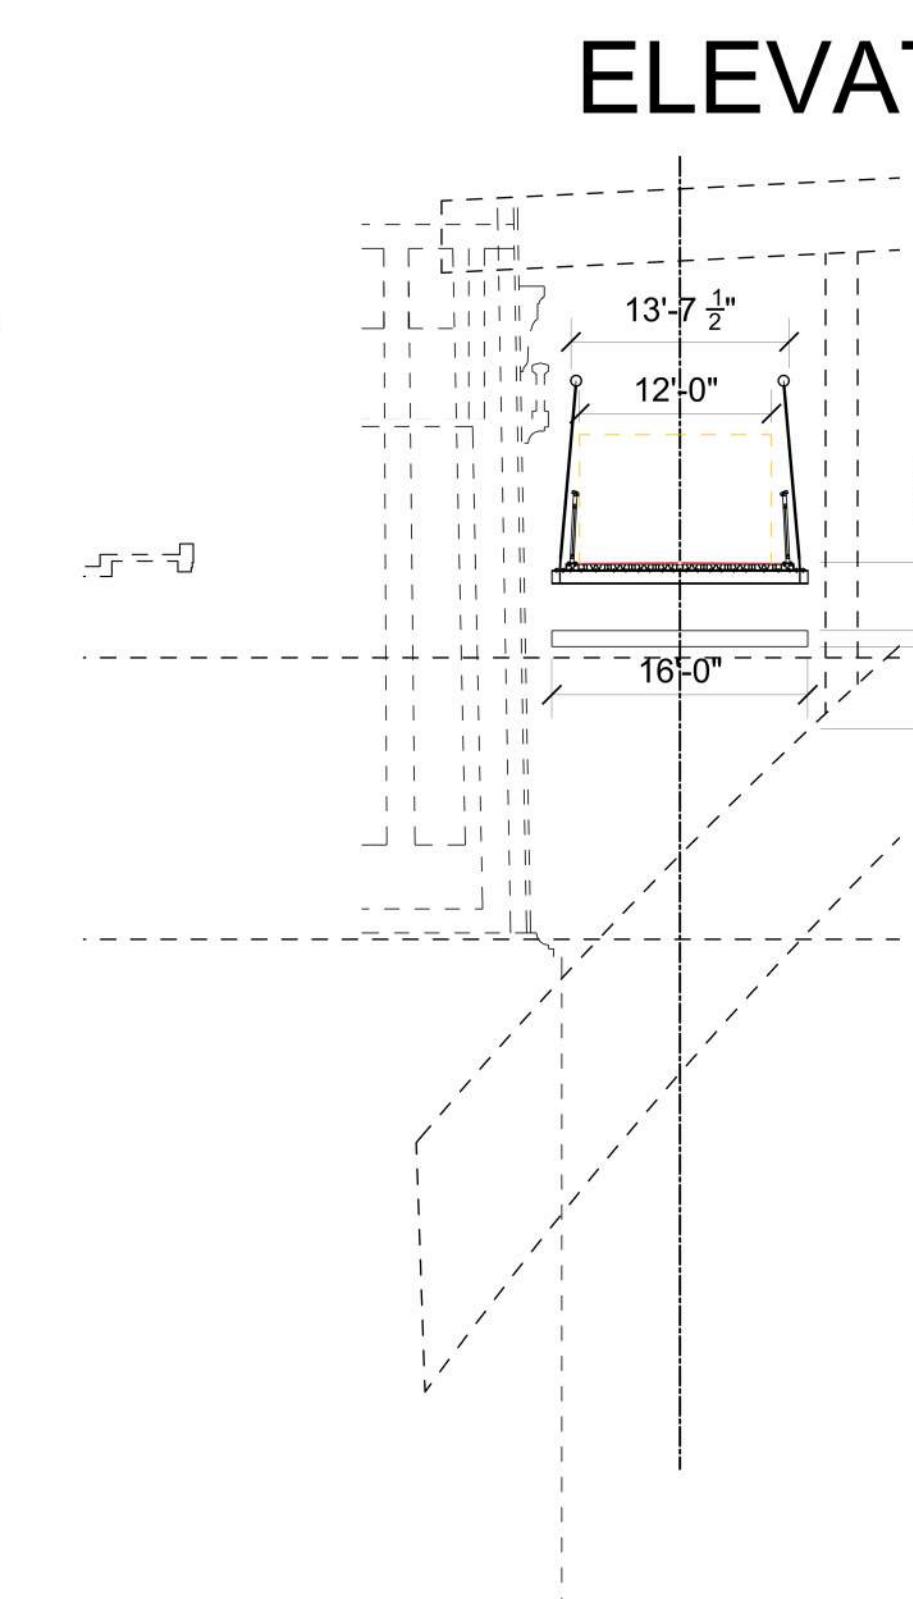
B-B: 550  
Scale 1"=12'-0"

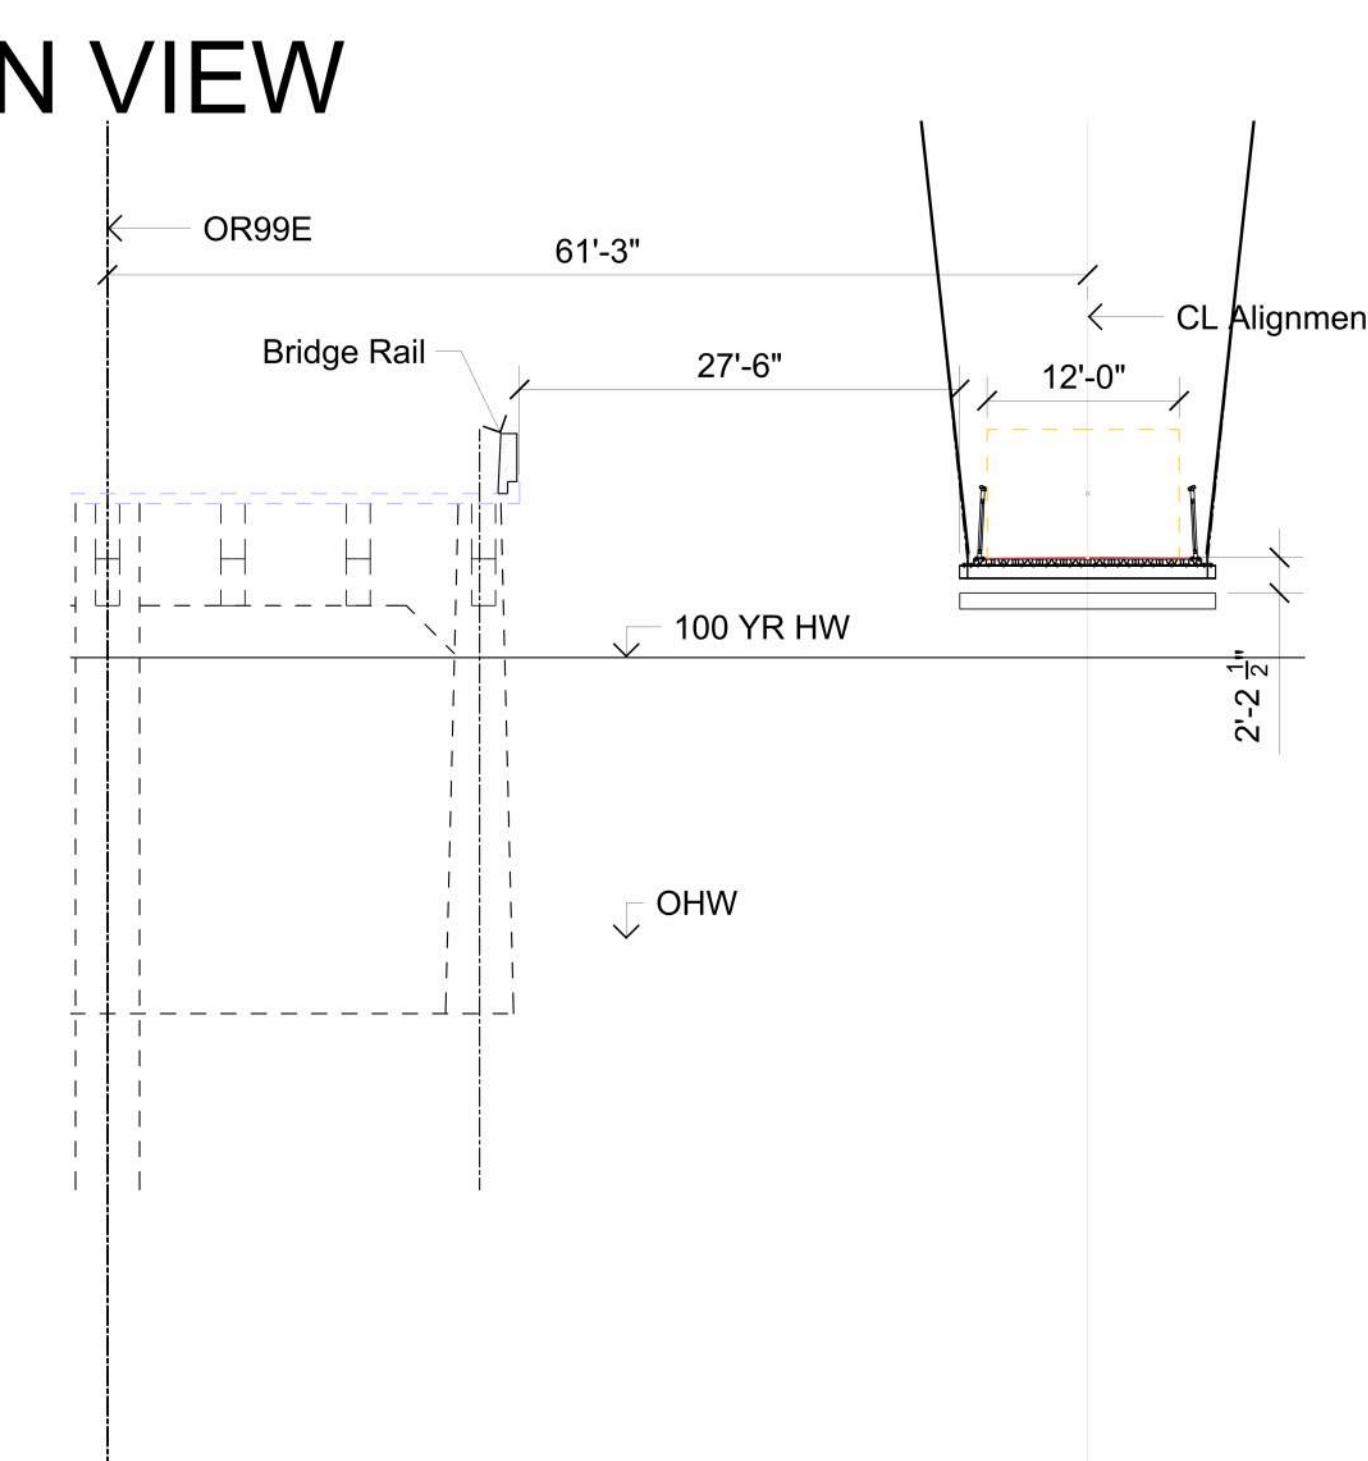
C-C: THRu Existing ARCH (1023)  
Scale 1"=12'-0"

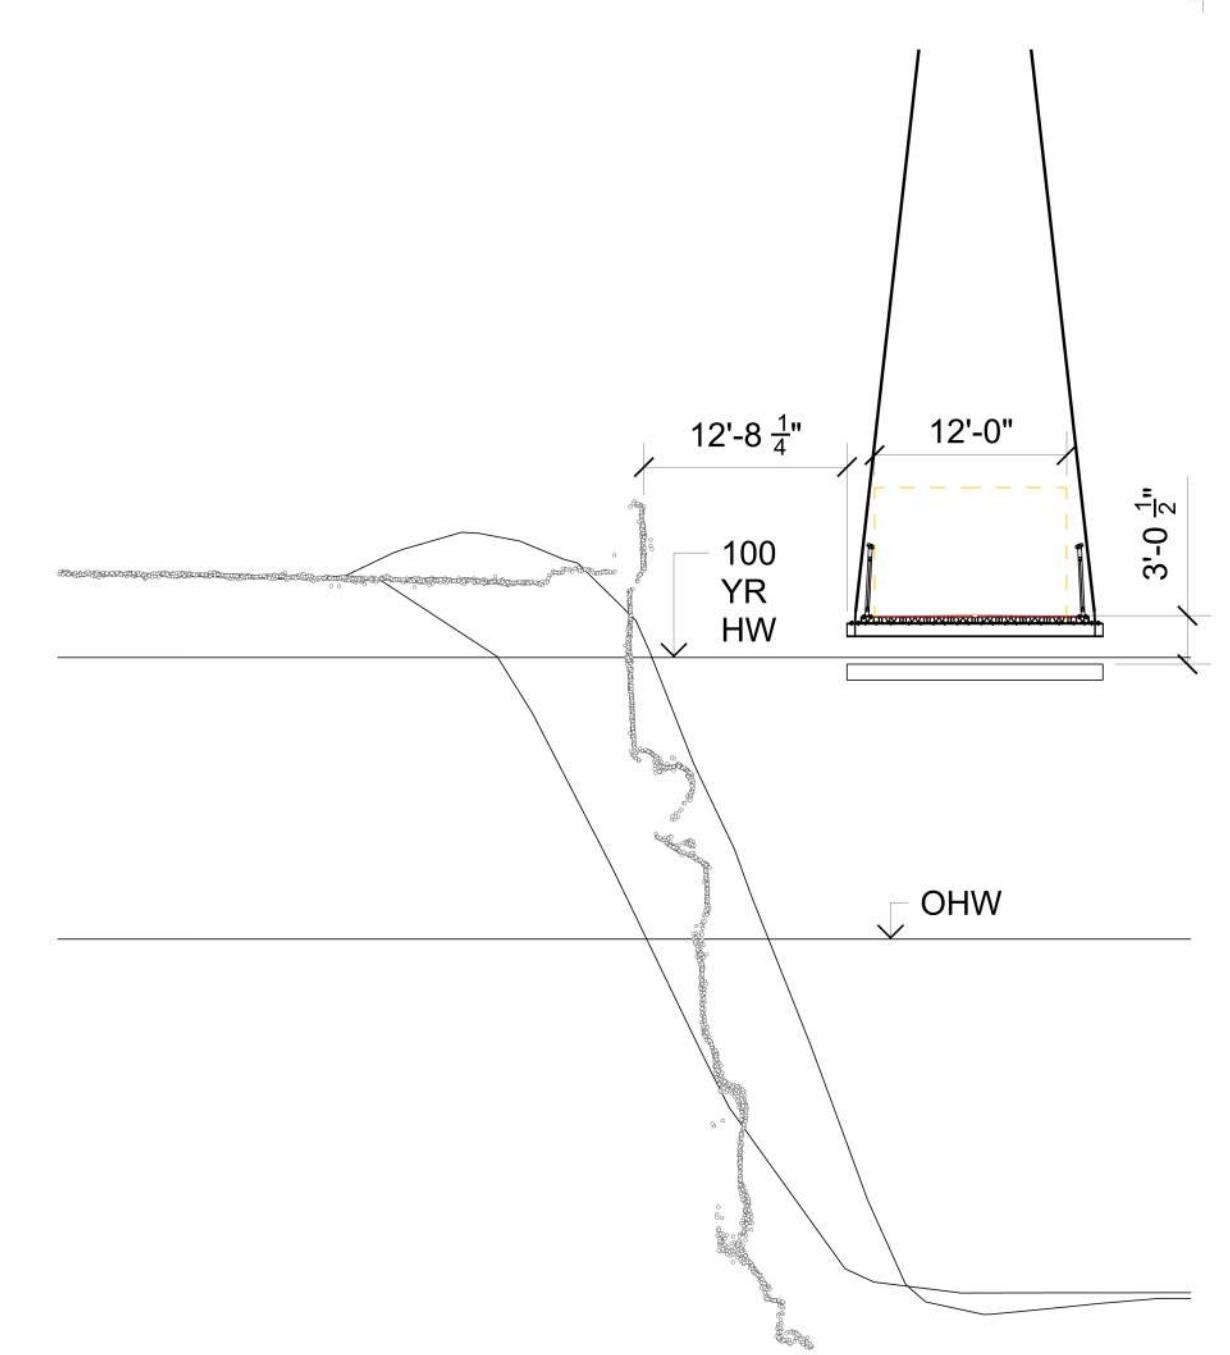
D-D: Section At (E) Bent 6 (590)  
Scale 1"=12'-0"

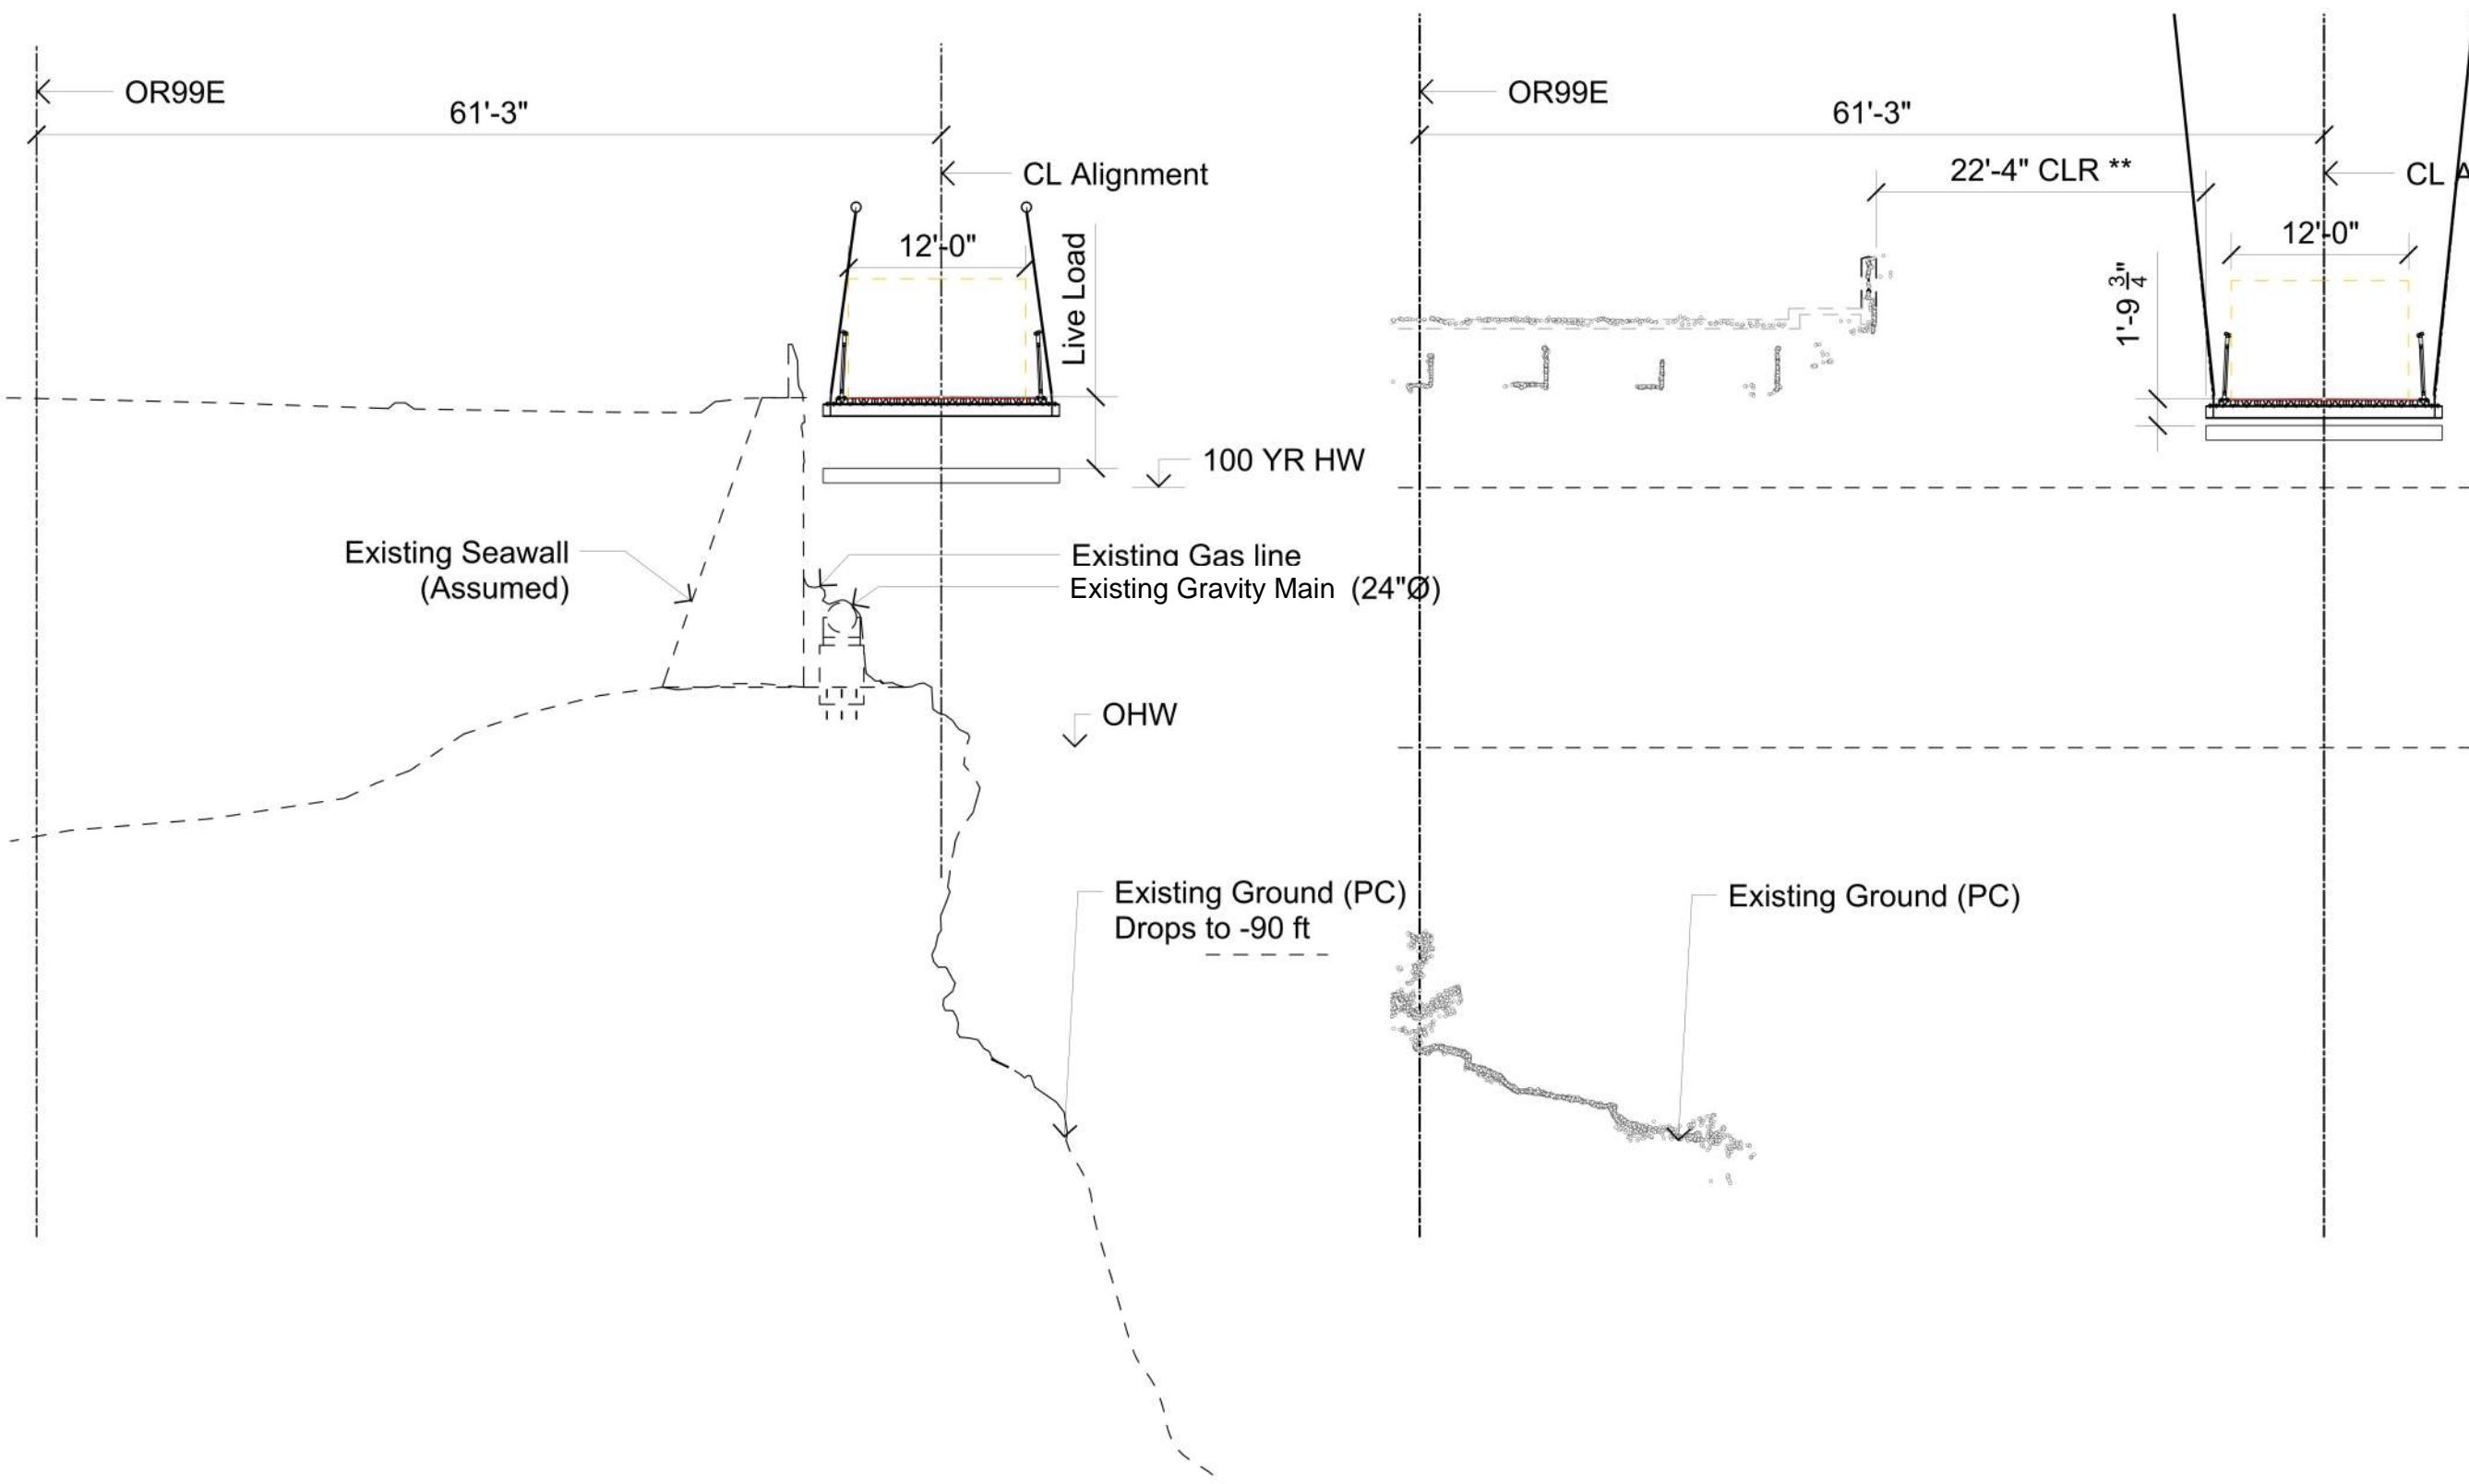
ELEVATION VIEW

A-A: Section At B10/B11 (1080)  
Scale 1"=12'-0"

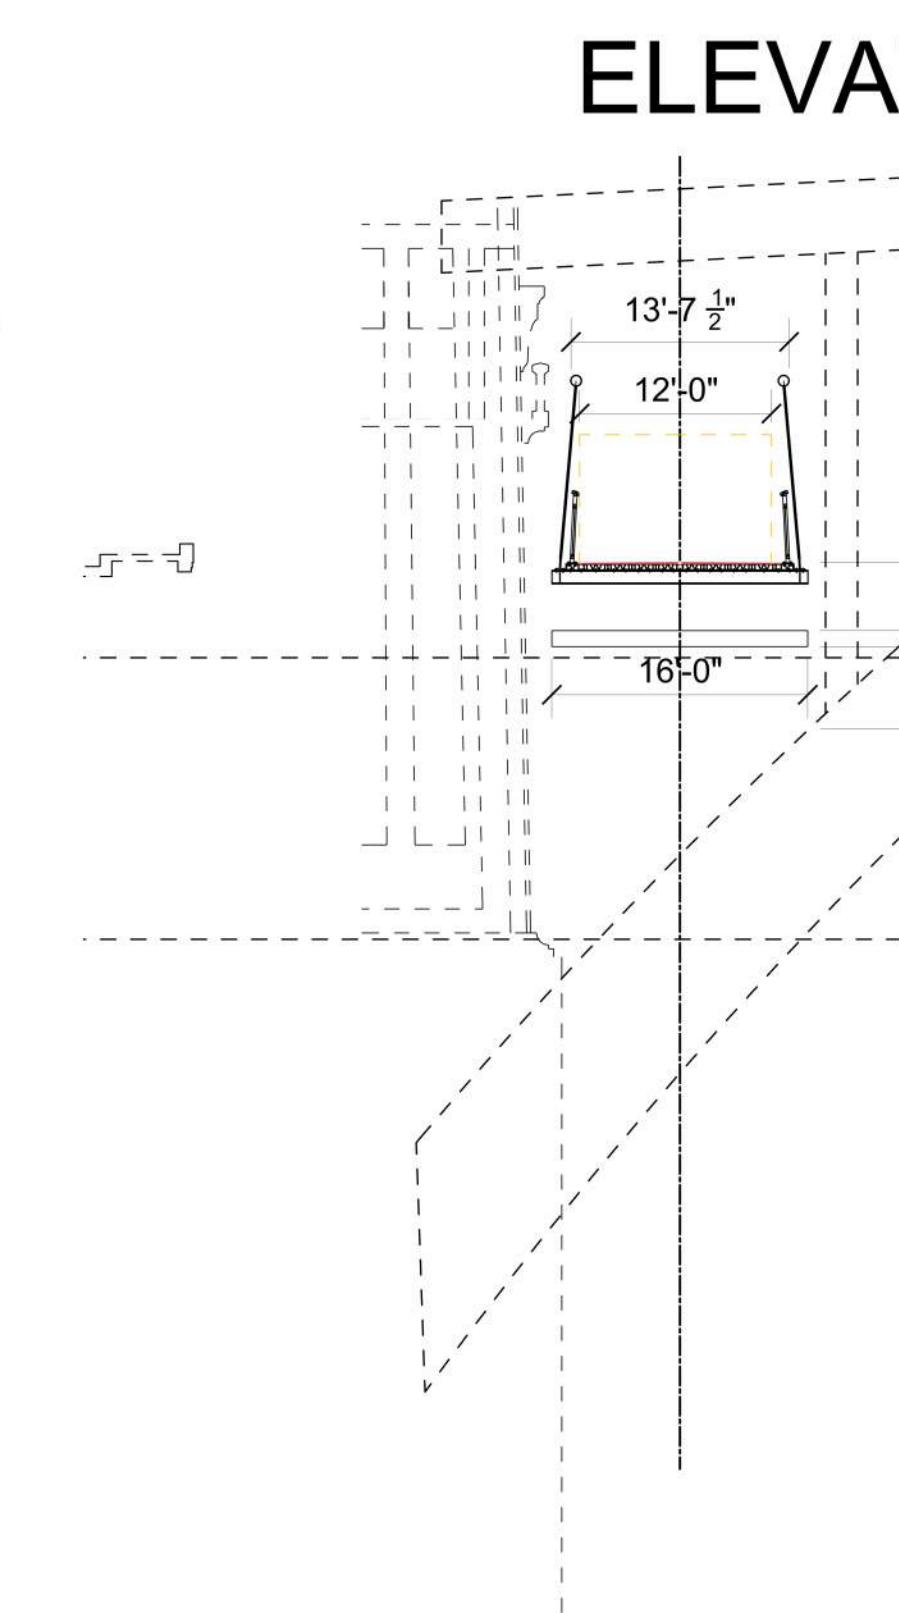
B-B: 550  
Scale 1"=12'-0"

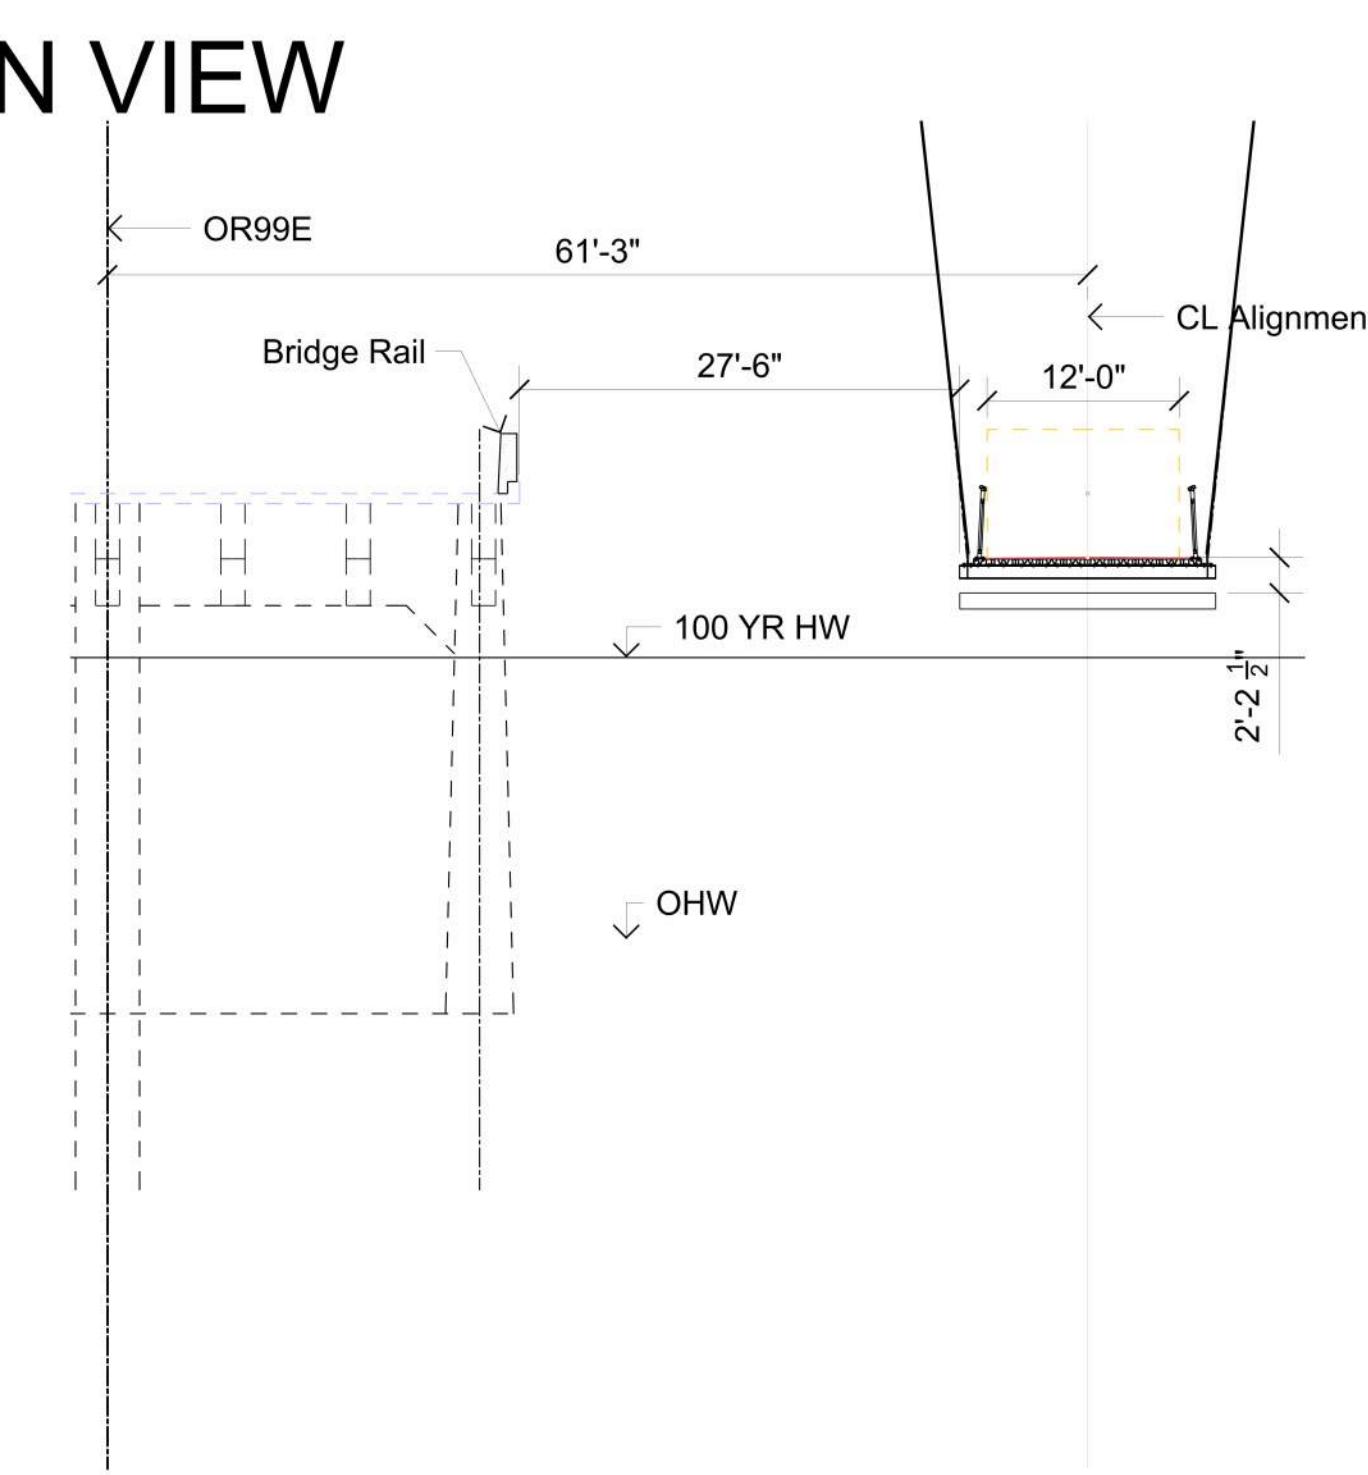
C-C: THRu Existing ARCH (1023)  
Scale 1"=12'-0"
