# TECHNICAL MEMORANDUM

RE: 3.3.3B - TM#6: Most Promising Alternatives  
McLoughlin Boulevard Enhancements - 10th Street to tumwata village

## Executive Summary

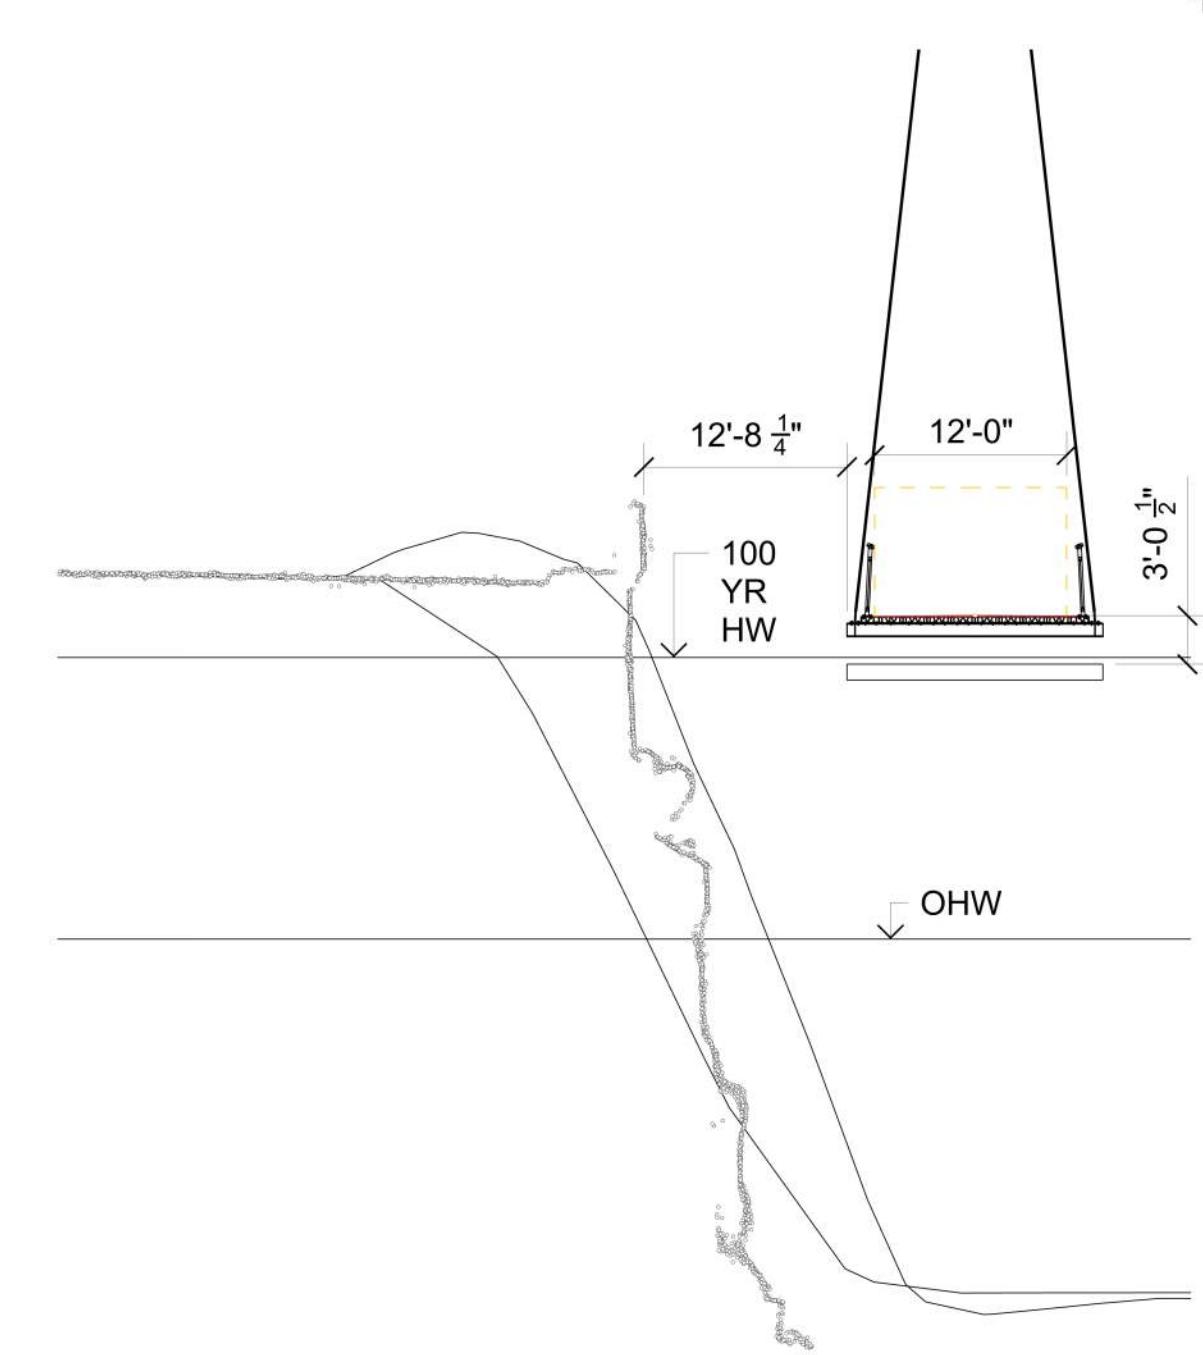
D-D: Section At (E) Bent 6 (590)  
Scale 1"=12'-0"
