# **Wesley Lynn Dog Park**

## **Concept Plan Options**

**December 10, 2024**

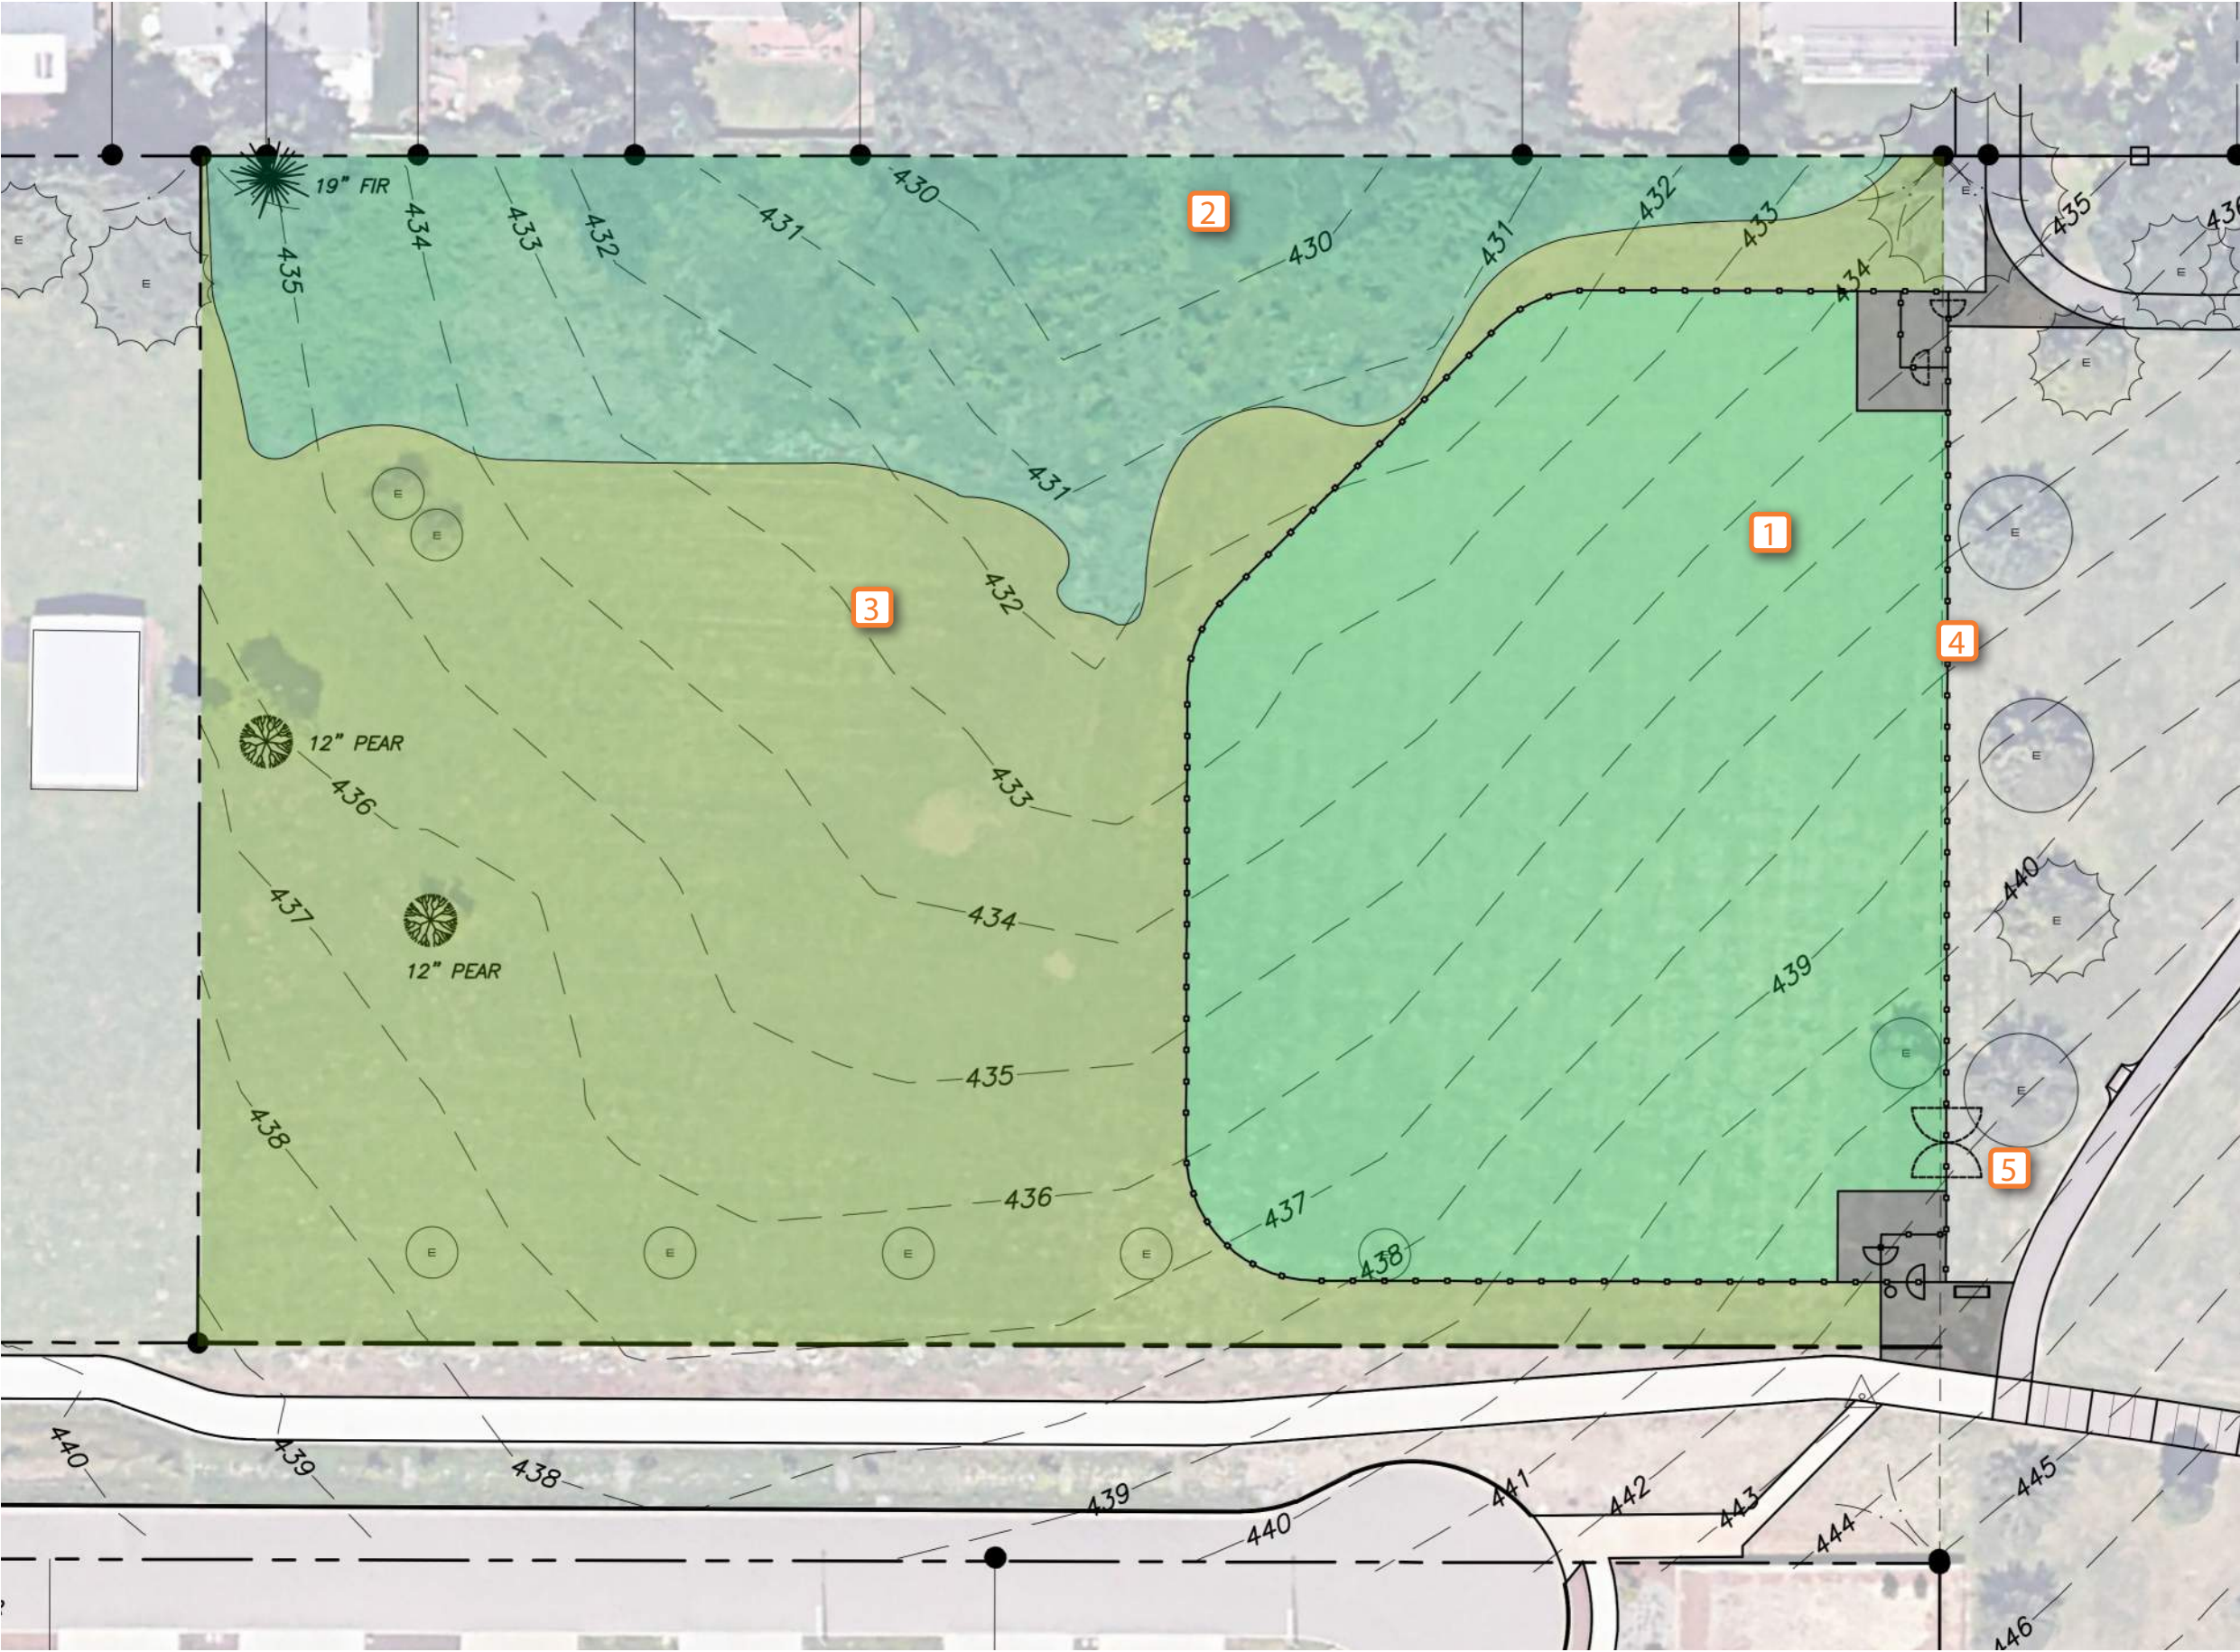
Option 1a

- 1 OFF-LEASH AREA (0.82 AC)
- 2 EXISTING WETLAND (0.50 AC)
- 3 RESTORATION PLANTING (1.20 AC)
- 4 4' CHAIN LINK FENCE, TYP.
- 5 16' MAINTENANCE ACCESS GATES

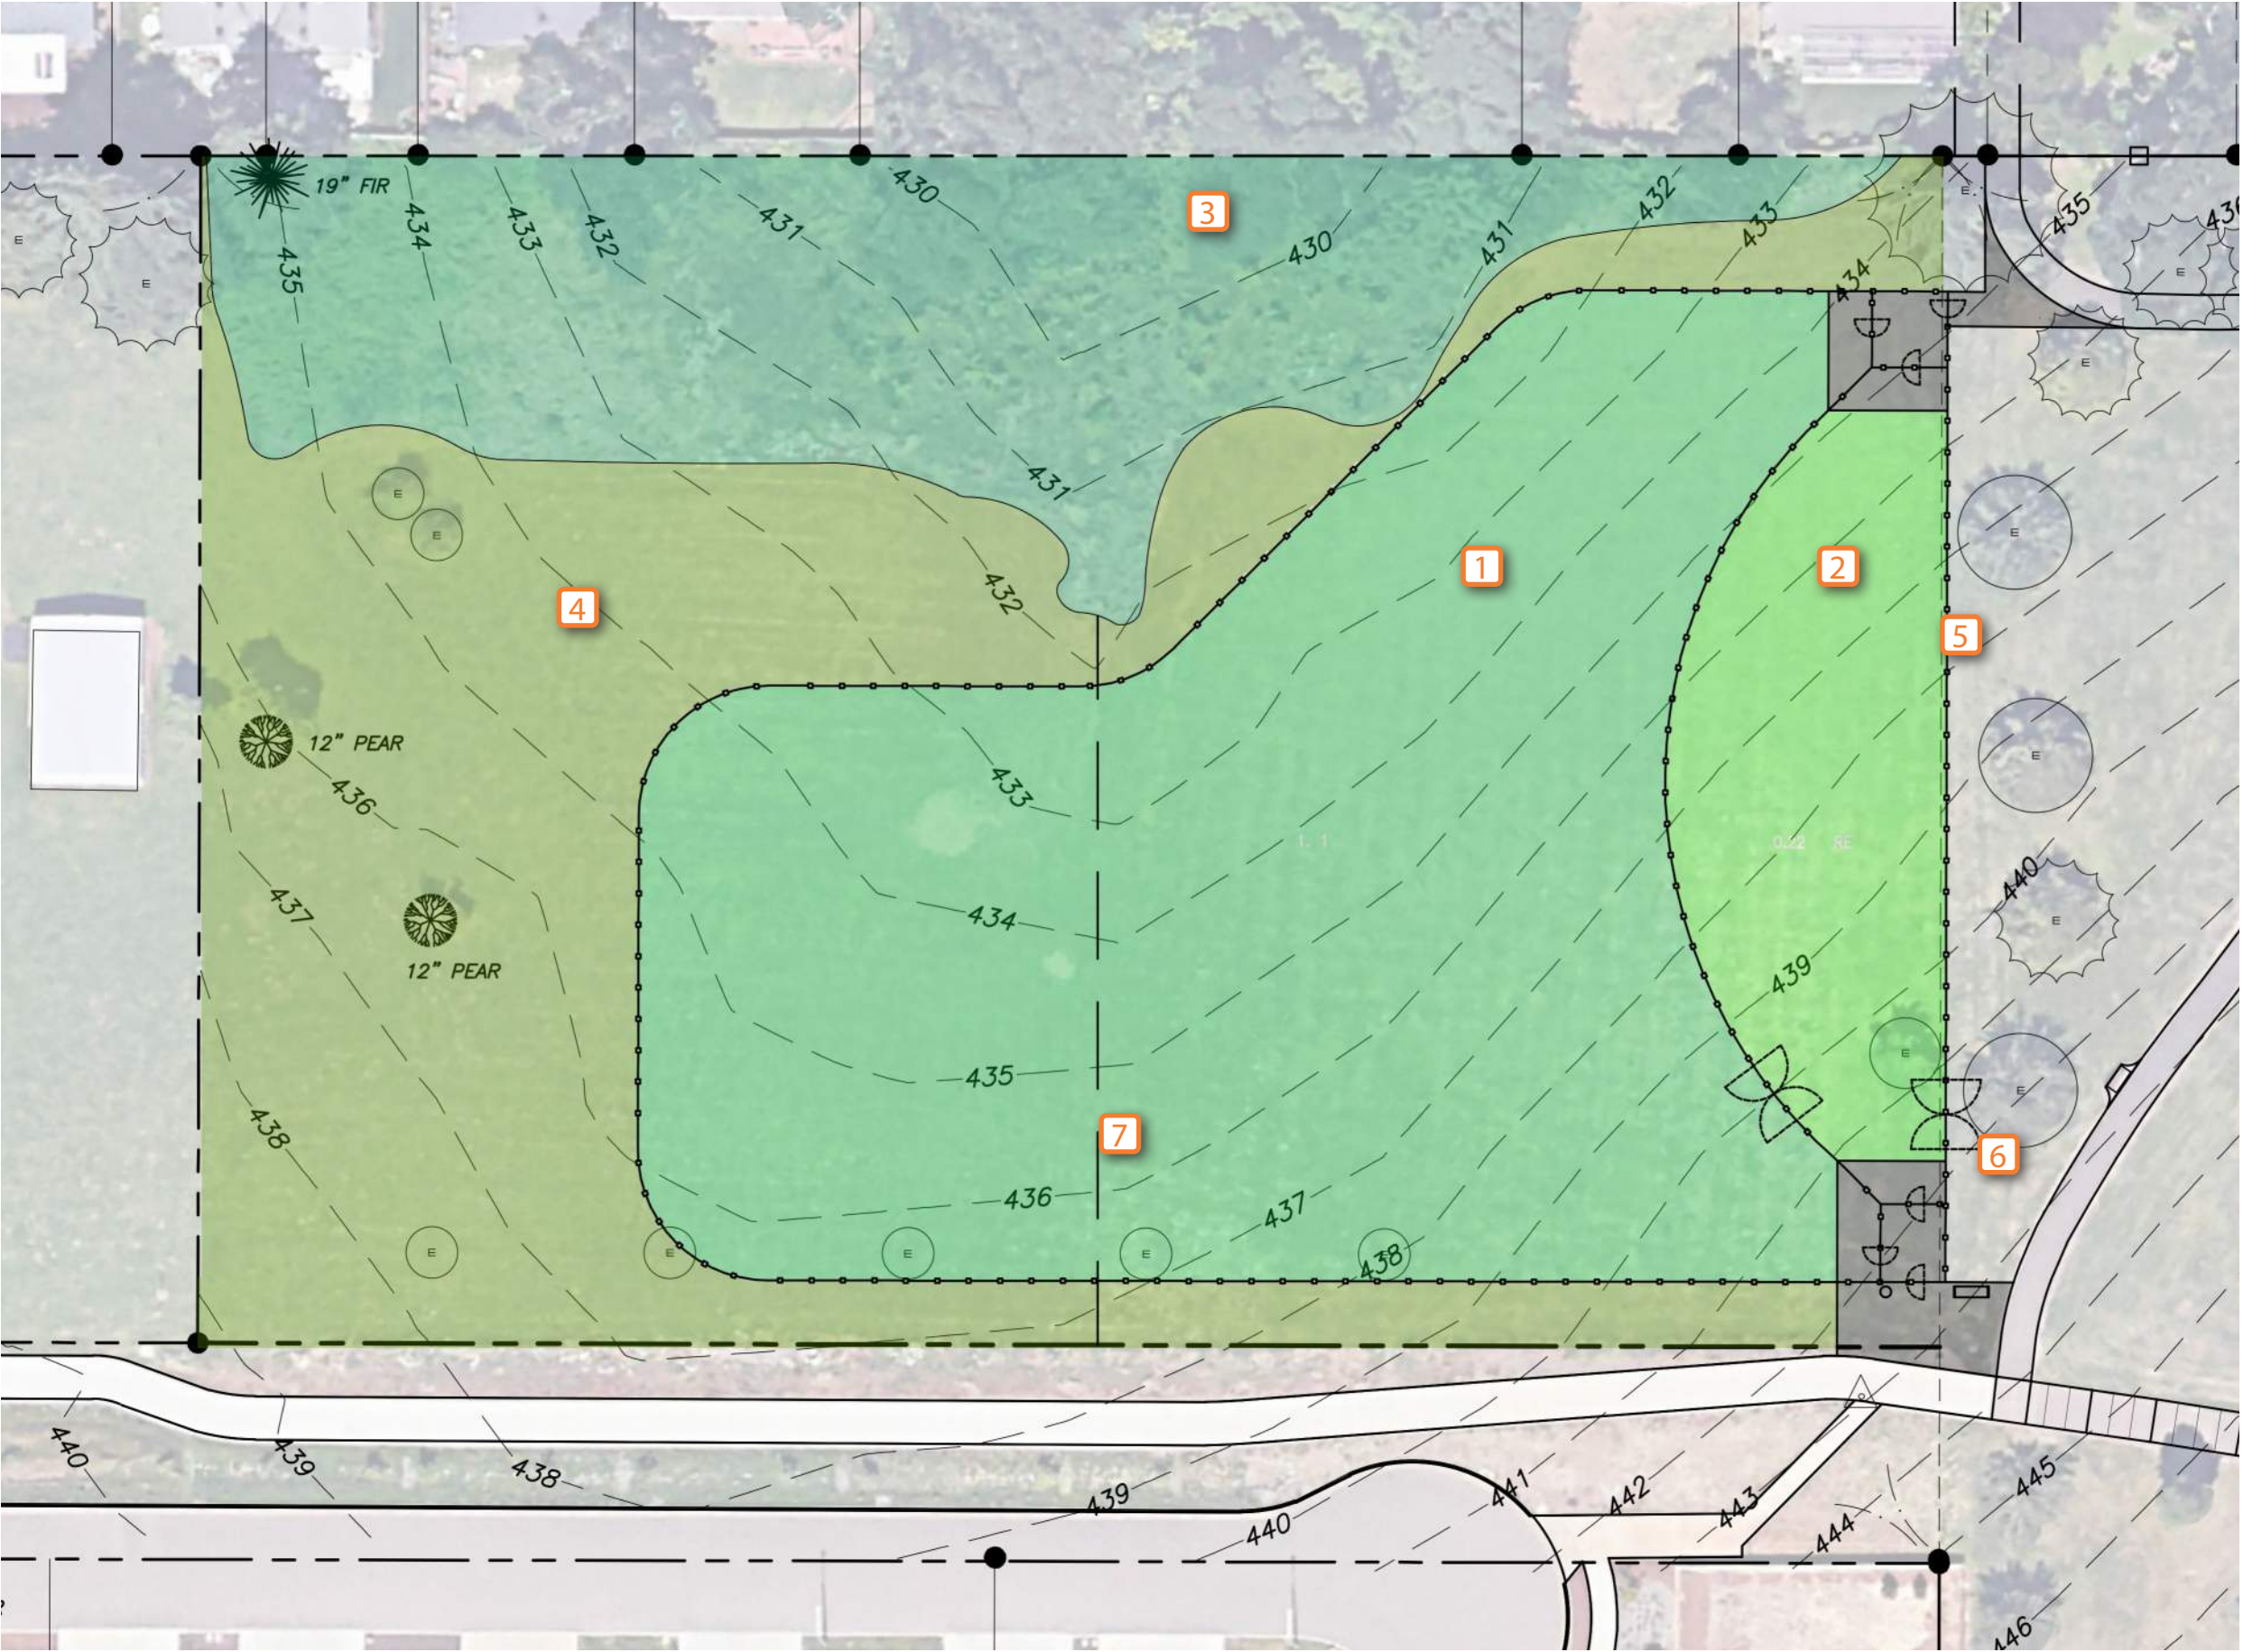
Option 1b

- 1 LARGE DOG AREA (1.01 AC)
- 2 SMALL/TIMID DOG AREA (0.22 AC)
- 3 EXISTING WETLAND (0.50 AC)
- 4 RESTORATION PLANTING (0.80 AC)
- 5 4' CHAIN LINK FENCE, TYP.
- 6 16' MAINTENANCE ACCESS GATES
- 7 HARD PIPED DRAINAGE CONNECTION

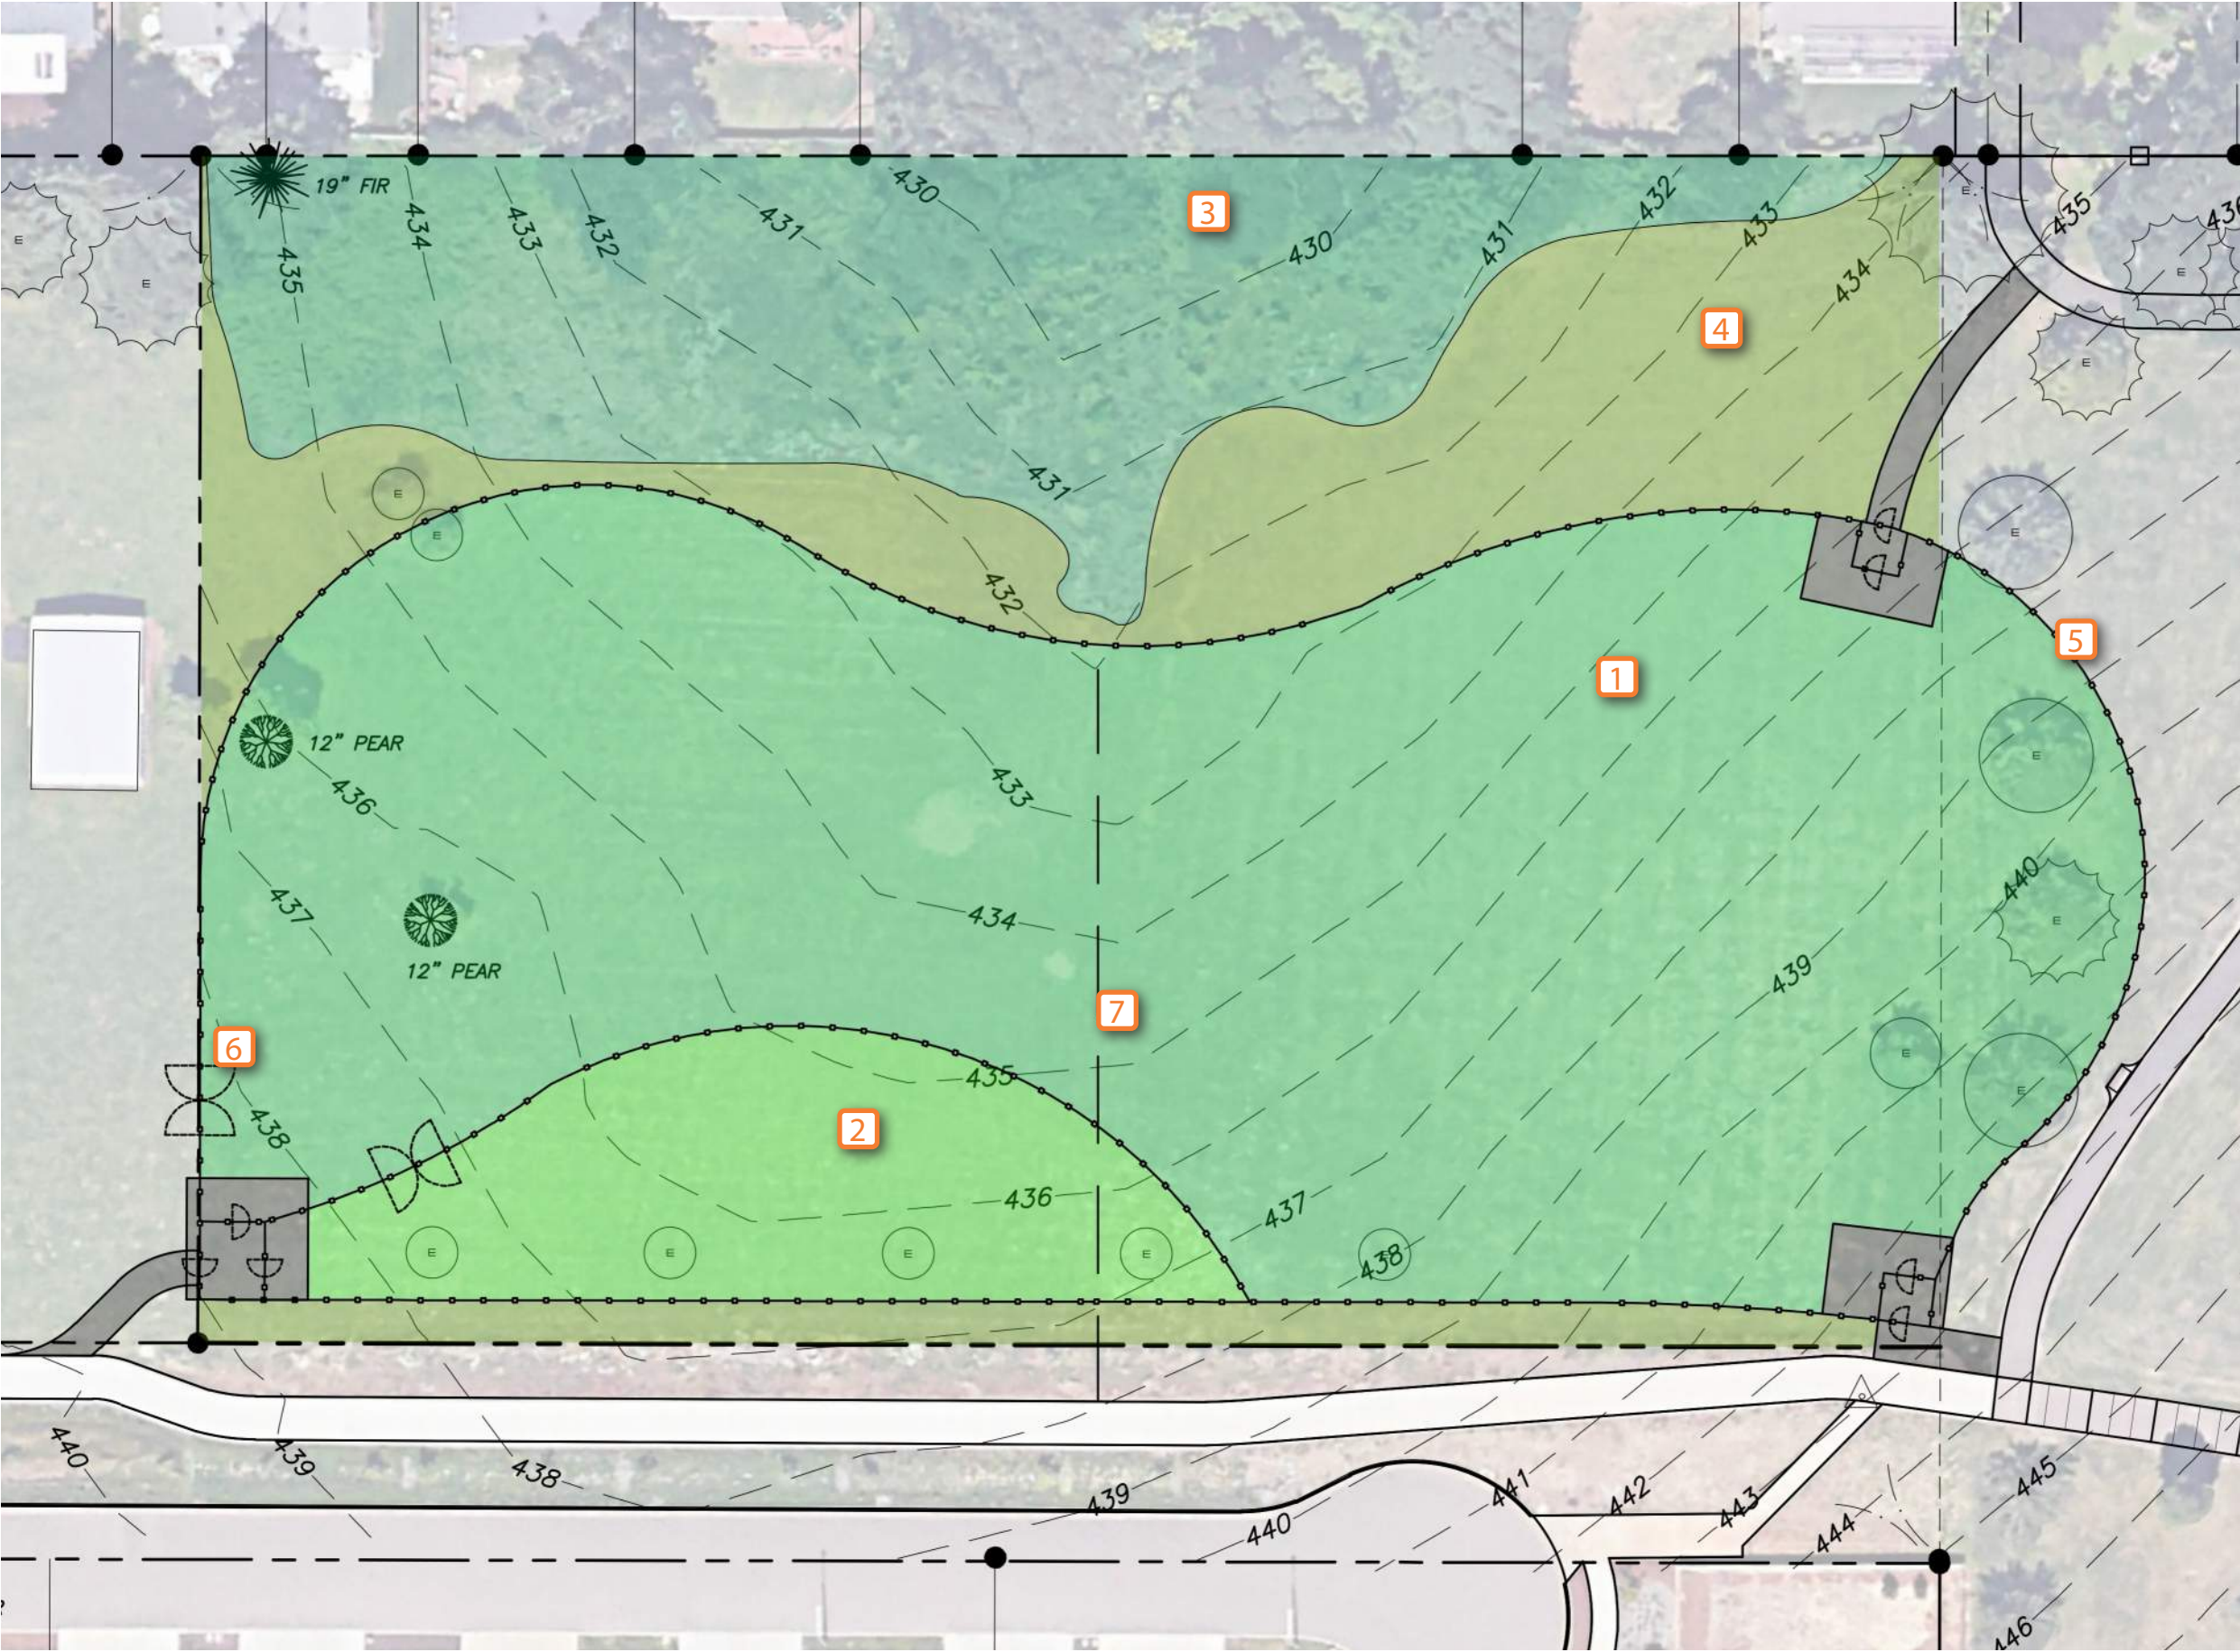
Option 2

- 1 LARGE DOG AREA (1.44 AC)
- 2 SMALL/TIMID DOG AREA (0.23 AC)
- 3 EXISTING WETLAND (0.50 AC)
- 4 RESTORATION PLANTING (0.63 AC)
- 5 4' CHAIN LINK FENCE, TYP.
- 6 16' MAINTENANCE ACCESS GATES
- 7 HARD PIPED DRAINAGE CONNECTION
